City of Evansville
Youth Center Board Meeting
Evansville Youth Center, 209 South First Street
Monday, March 25th, 2024, 5:30 pm

Evansville Youth Center Conditions Assessment

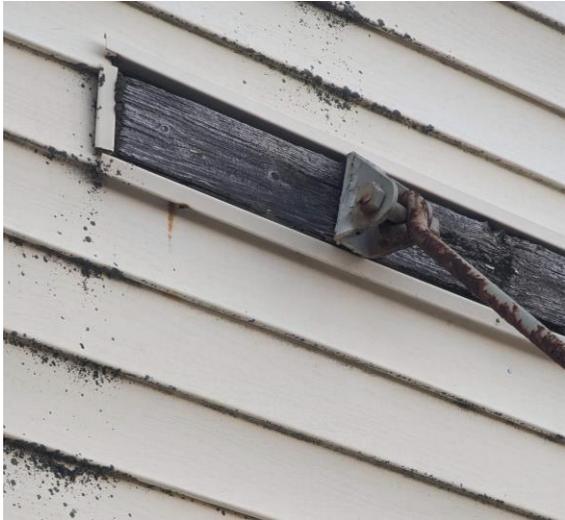
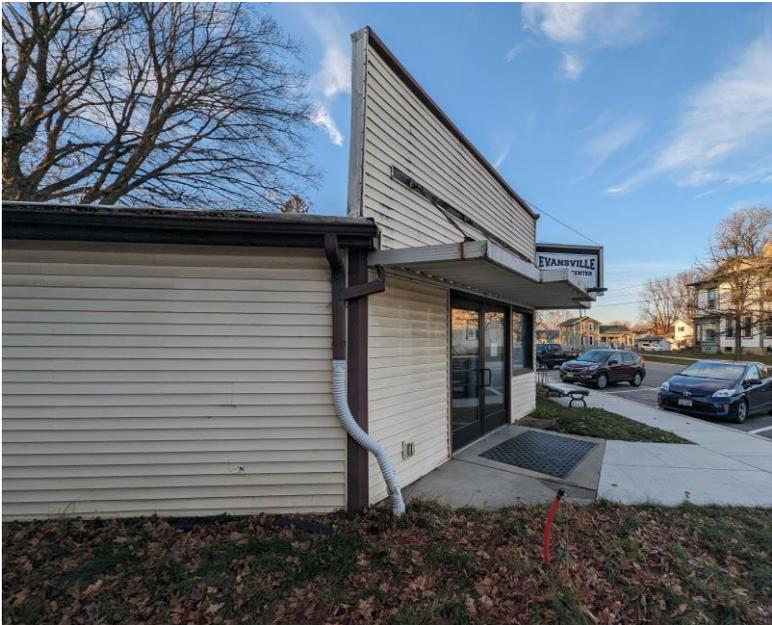
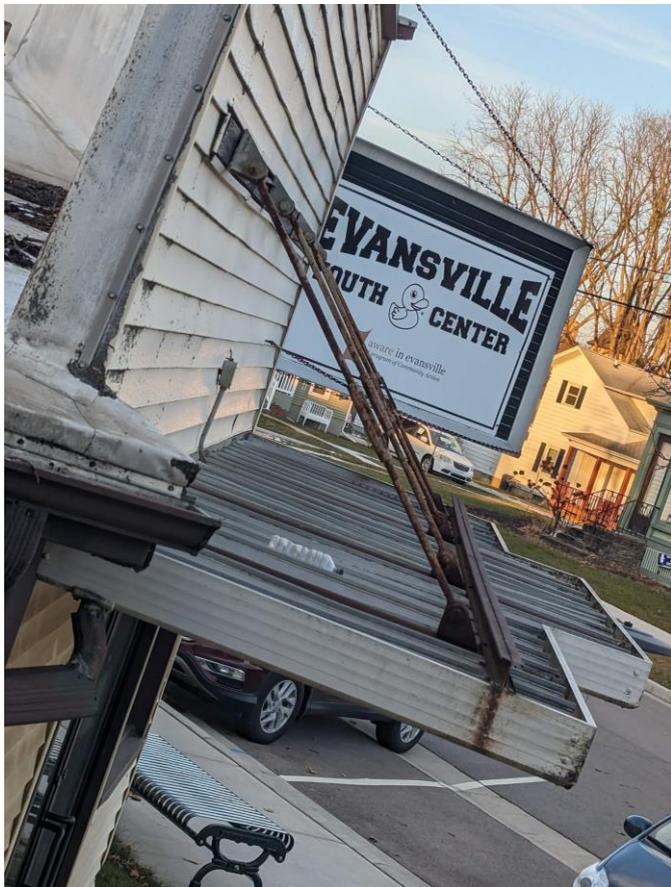
The structure is a mix of 4 to 5 buildings/additions combined. Some with basement space, unexcavated areas and others with the building extended over slab on grade conditions. Exterior is vinyl sided on street side. Rear side is combination of wood and pressed board siding.

The entry doors of the building were recently replaced and are in good condition. The entry overhang is deteriorating. The canopy is canting on the left side. The blocking is wood rotted and tie rods are releasing. Repair, stabilization or removal is required. The current condition may not support heavy snow loads or strong wind uplift. The unbraced parapet is showing signs of deterioration due to being undersized structurally.

Immediate Recommendation: Remove existing canopy prior to winter 2024 snowfall.

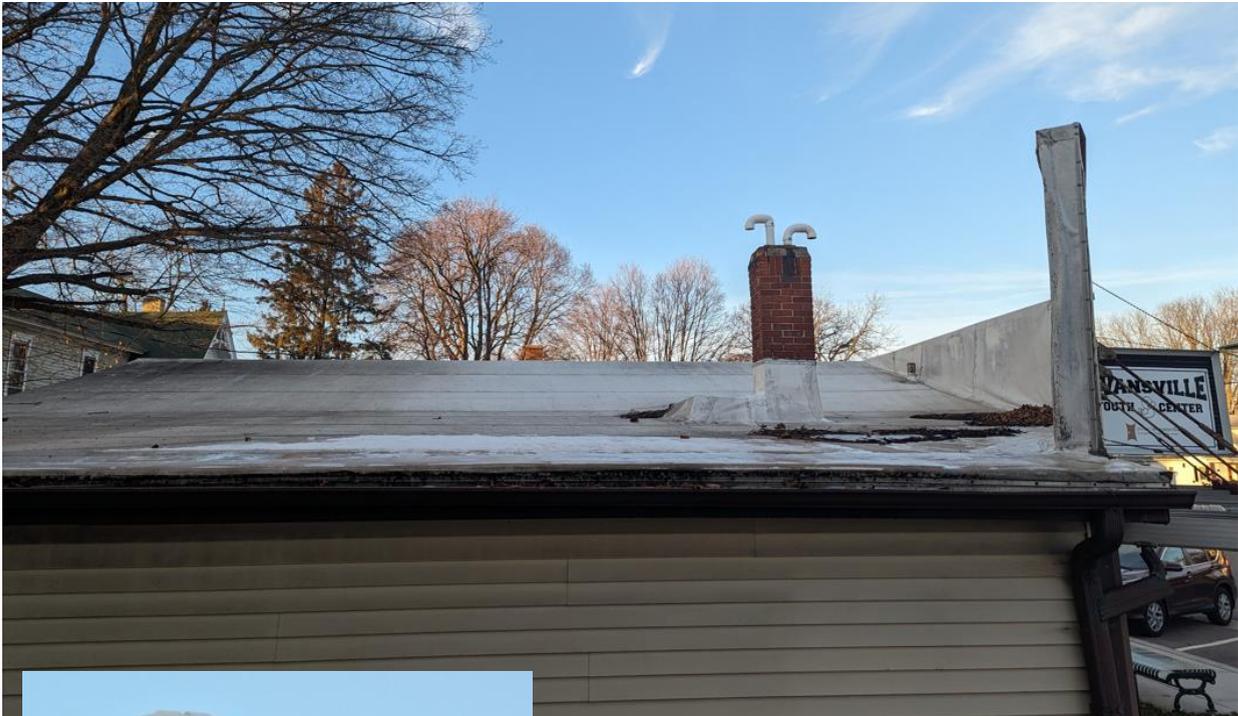
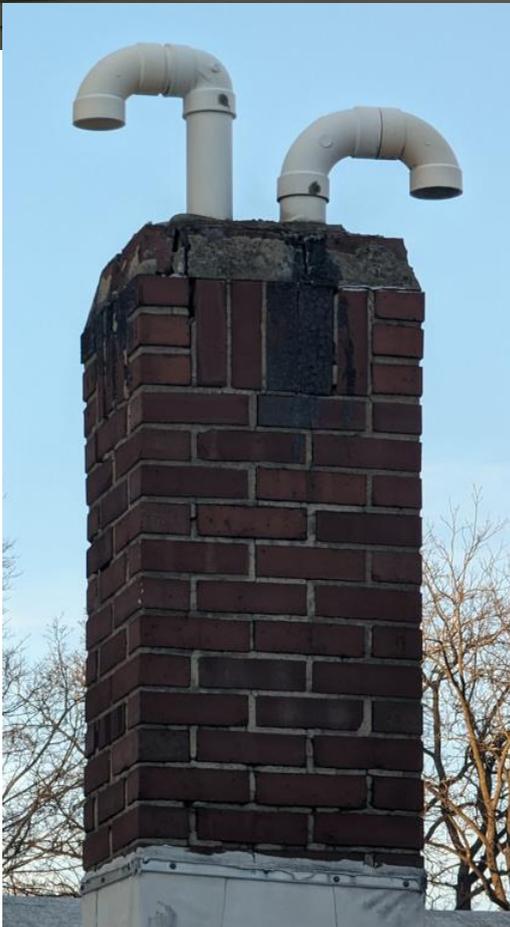
Roofing – there is a TPO white membrane on the roof. The roof framing displays evidence of unbraced and undersized members. There was evidence of water leaks in areas throughout the roof. Now fixed, however was detrimental to the structure and insulation is missing, damaged and underperforming.

Chimney is abandoned and used only for mechanical venting, however cap requires maintenance to eliminate water infiltration.

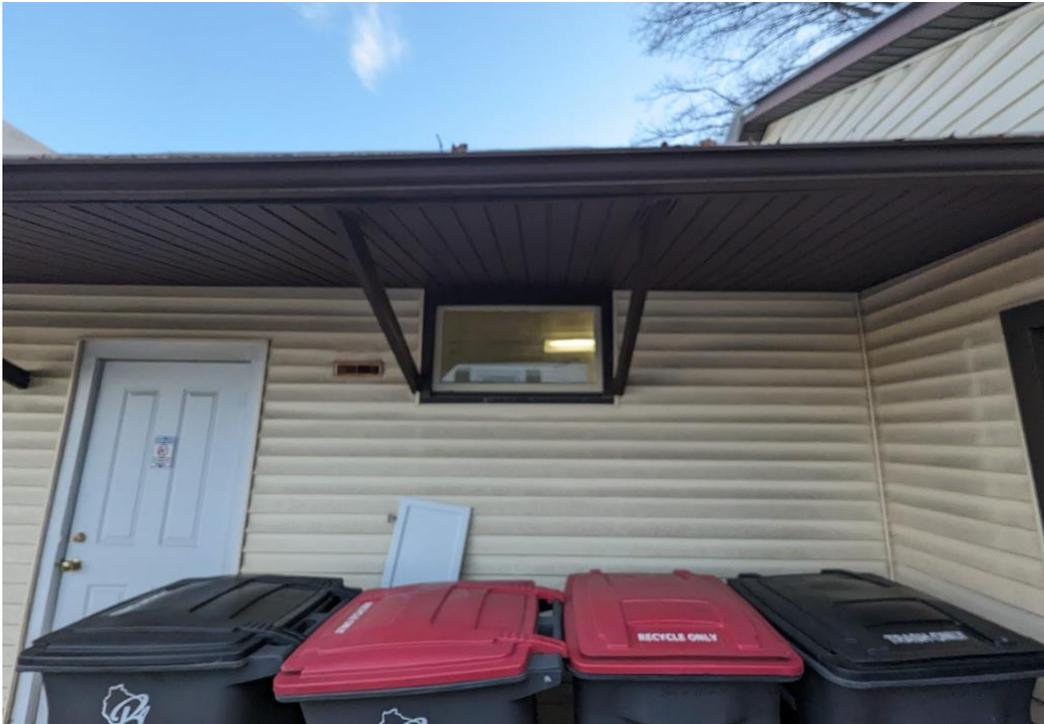
The north roof overhang is sagging. The existing bracing is not properly reinforcing the roof framing. The trash cans being located on the side yard is a visual eyesore.

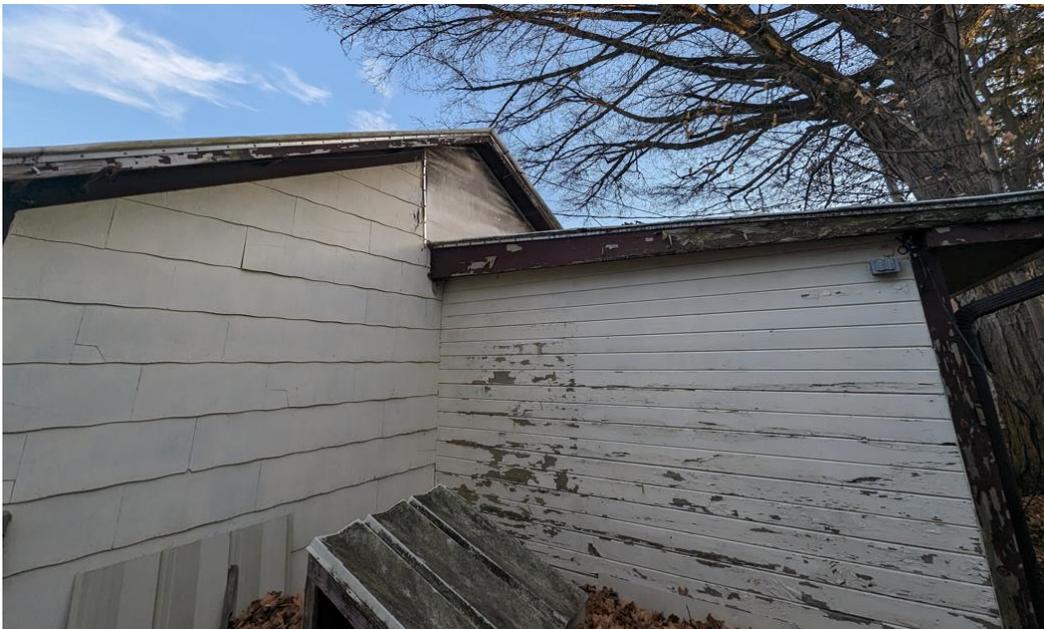
The rear of the youth center is a combination of pressed siding and wood siding. The fascia's all have significant wood rot. The exterior is poorly maintained and an eyesore to the adjacent property owners.

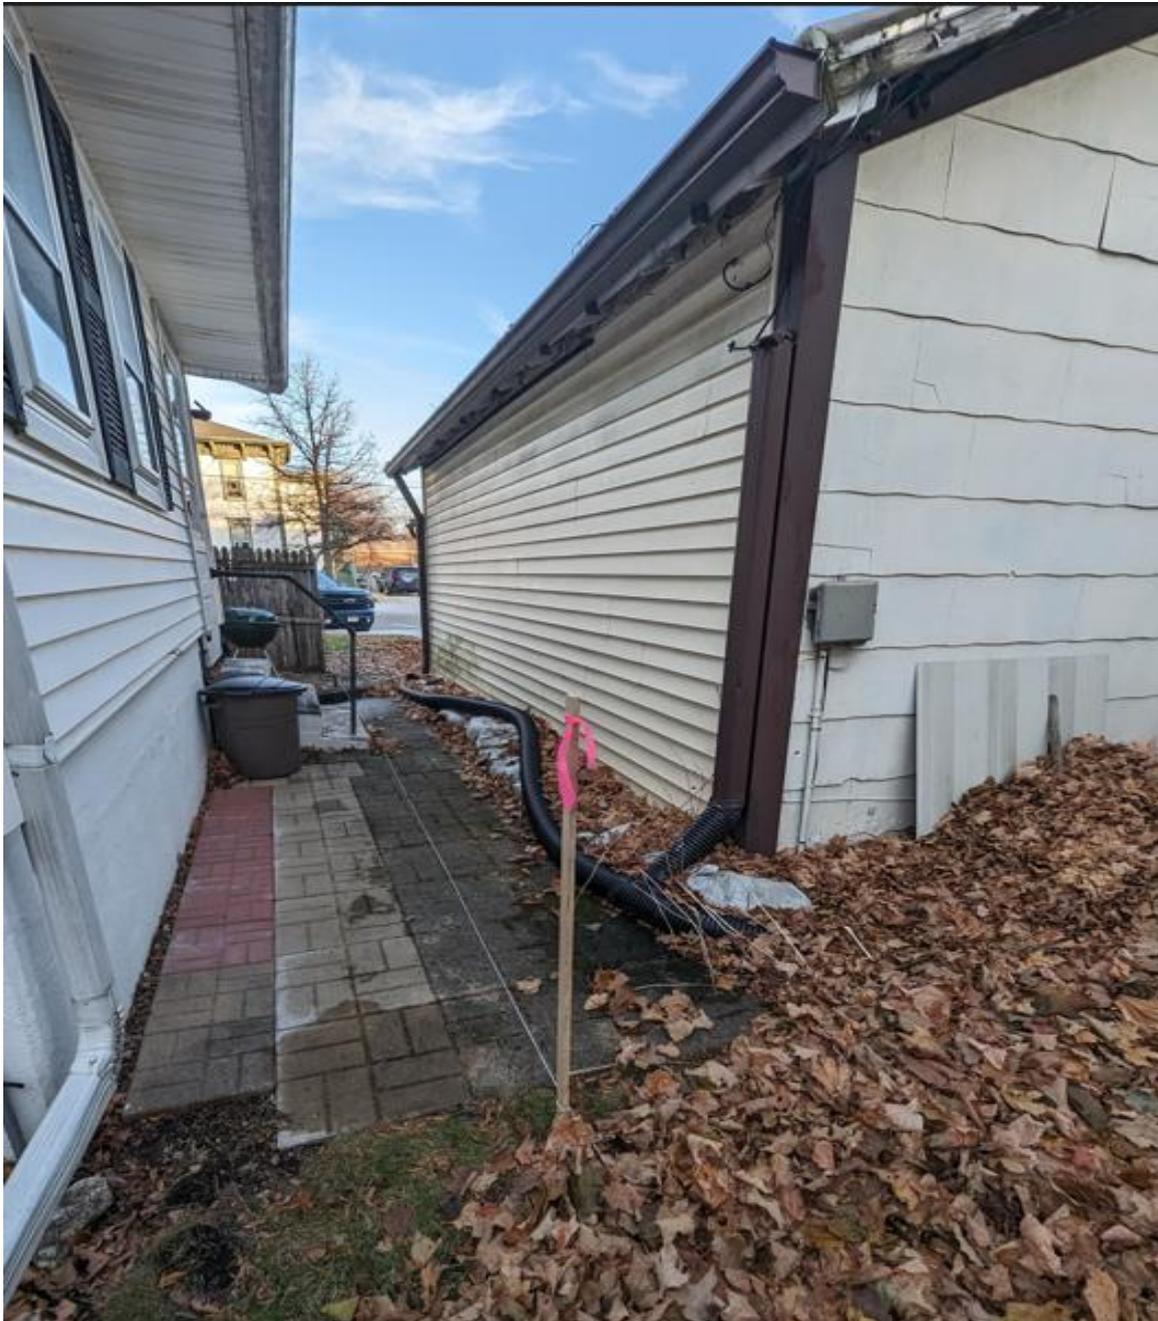
This image shows many challenges related to the small side yard and water management. The side yard is very tight, the grading is flat and pitching toward the EYC, rubber hoses are attempting to move water to the street, sand bags have been placed on the base of the wall (under the leaves) to control water. This condition is allowing water infiltration into the EYC building. This is not an acceptable long-term solution.

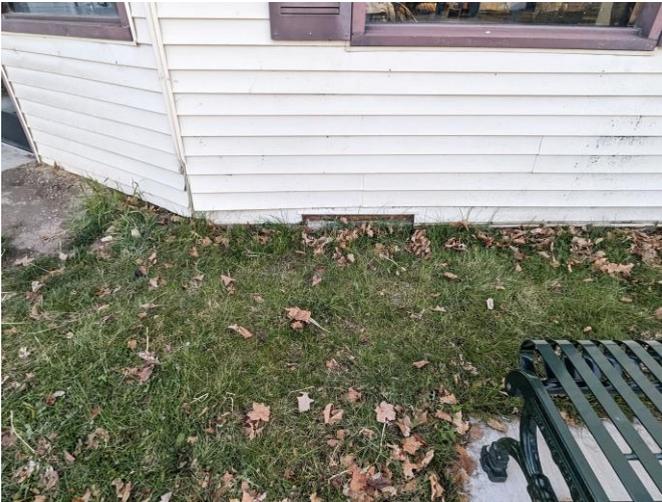
The site is flat, there is no positive grading away from the building, water susceptible building materials are deteriorating and too close to grade. 8" above grade for wood is required by code.

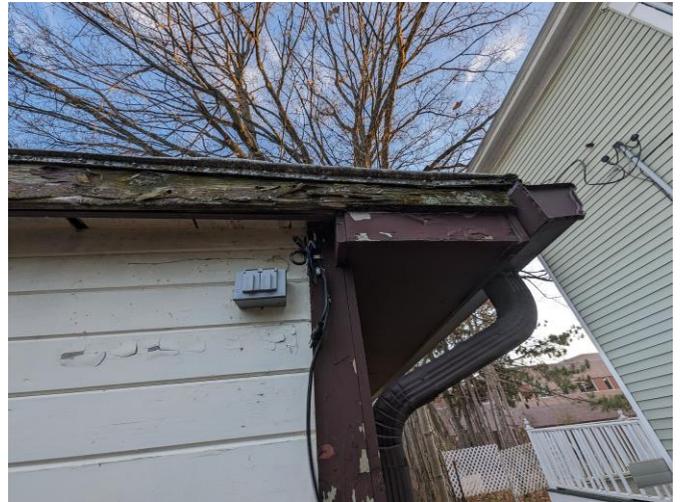
Excessive wood rot. Electrical was added to this location and it appears to have electric heat tape to avoid ice damming. This is a water infiltration area due to lack of insulation and modifying an old 'garage' into an interior space.

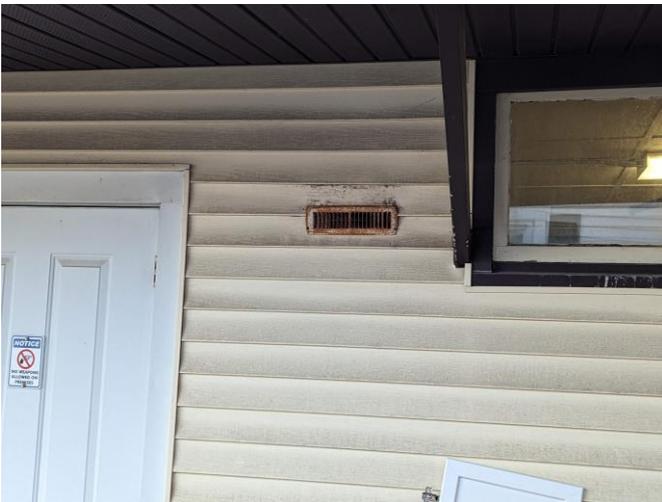
Rusted exterior exhaust vent. The building has many abandoned exterior penetrations, reflecting a concern for moisture migration through the exterior envelope and poor energy efficiency.

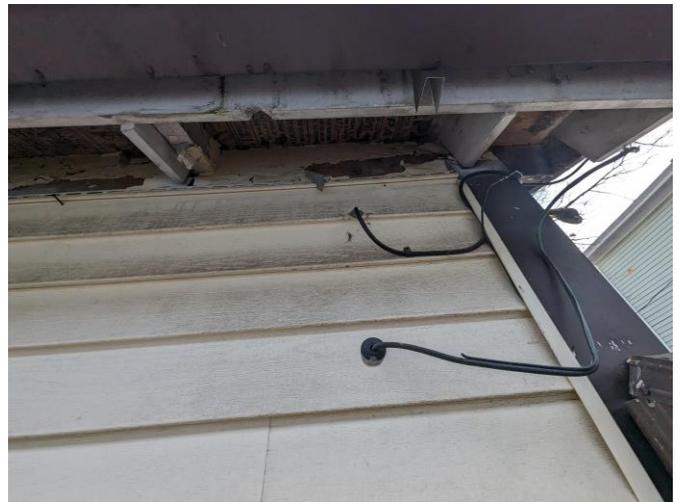
Perimeter of the building has various abandoned wires and heat tape. Electrical Services is in the rear of the building, overhead. Access is limited with the side yard of less than four feet.

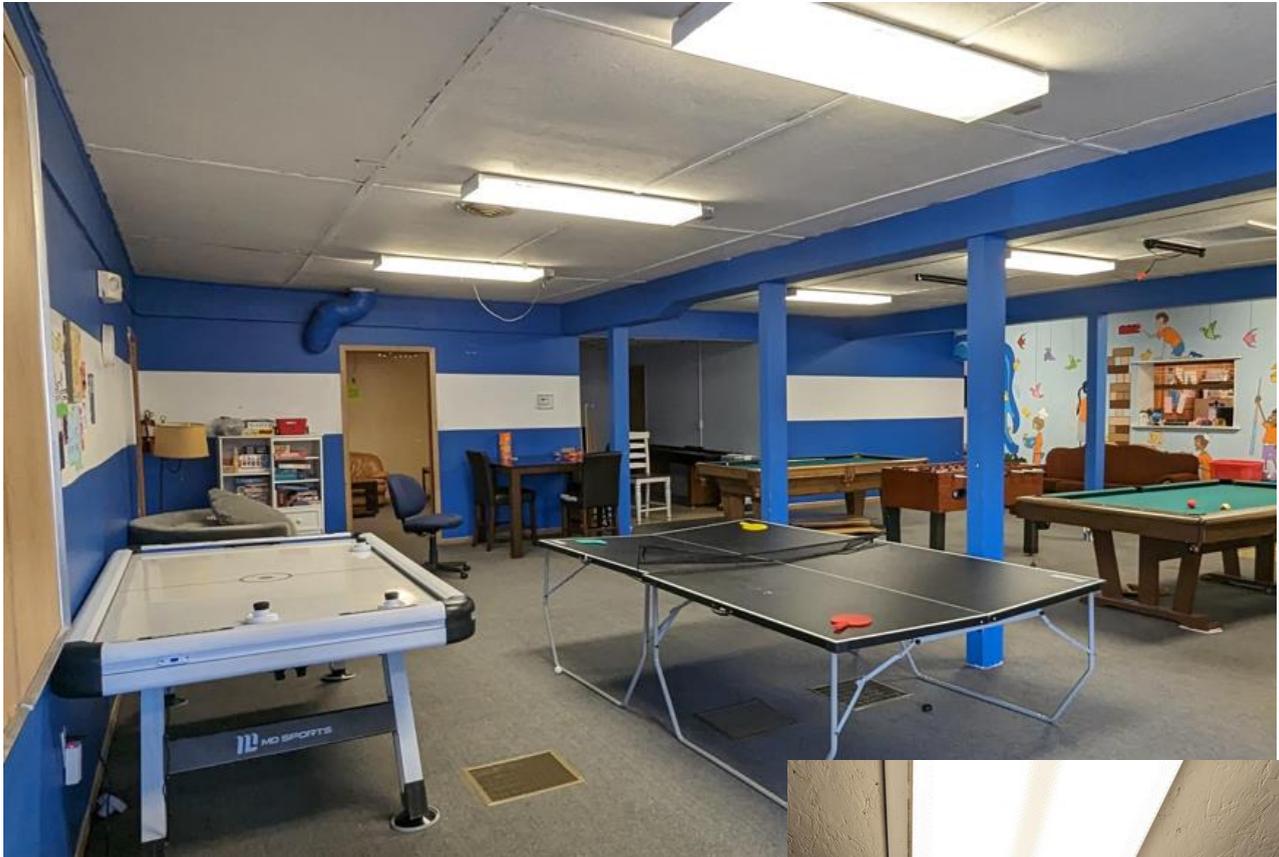
The existing 2500sf youth center provides services to a maximum of 40 students. Above is an image of the EYC open game area. The flooring is carpet, walls are drywall, and ceilings are wood panel board with surface mounted fluorescent lighting. The HVAC system supplies through the floor from the basement. There is a distinct odor of dampness upon entry into the building. There are multiple dehumidifiers on the main level, constantly running annually to address elevated levels of moisture in the building. Damp interior spaces create poor indoor air quality. There was no discoloration of materials observed during the December 2023 walk-thru. The moisture is assumed to be originating in the foundation/ basement area. Monitoring of indoor air quality and visual inspections for mildew are recommended.

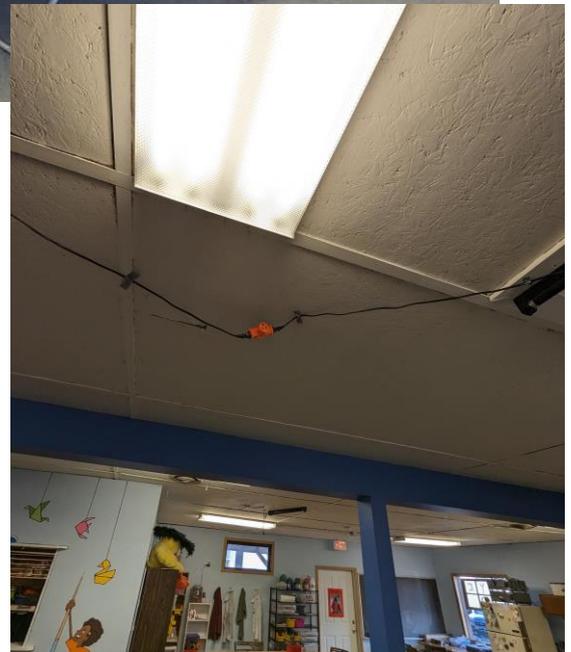
Extension cord at ceiling in game area. This is not allowed by fire code.

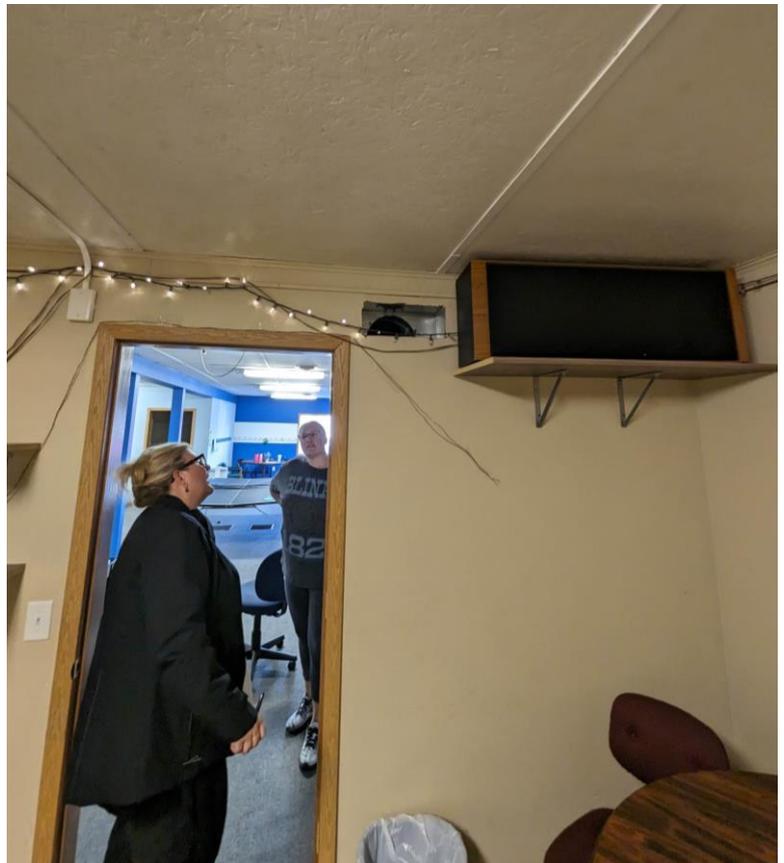
Existing Quiet room:

Supply grill missing at duct. Door opening is 32" wide. Noise is a concern with the adjacent game area. A new 36" door will need to be installed to accommodate accessibility clearances.

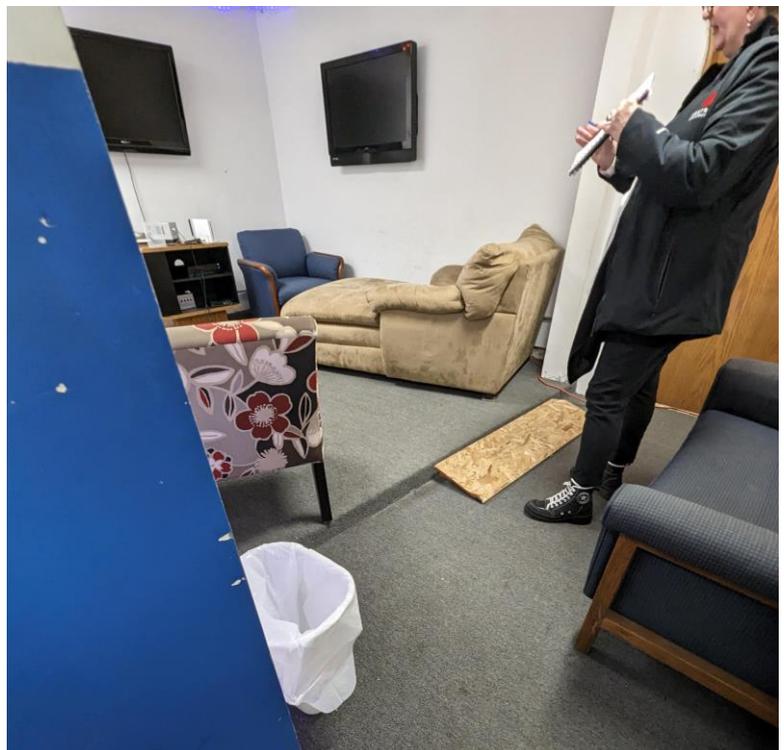
Electronic Gaming:

The floor slab is not at the same level. Particle board ramp element is in place. This is not safe. Code accommodations need to be made to resolve this lack of accessibility.

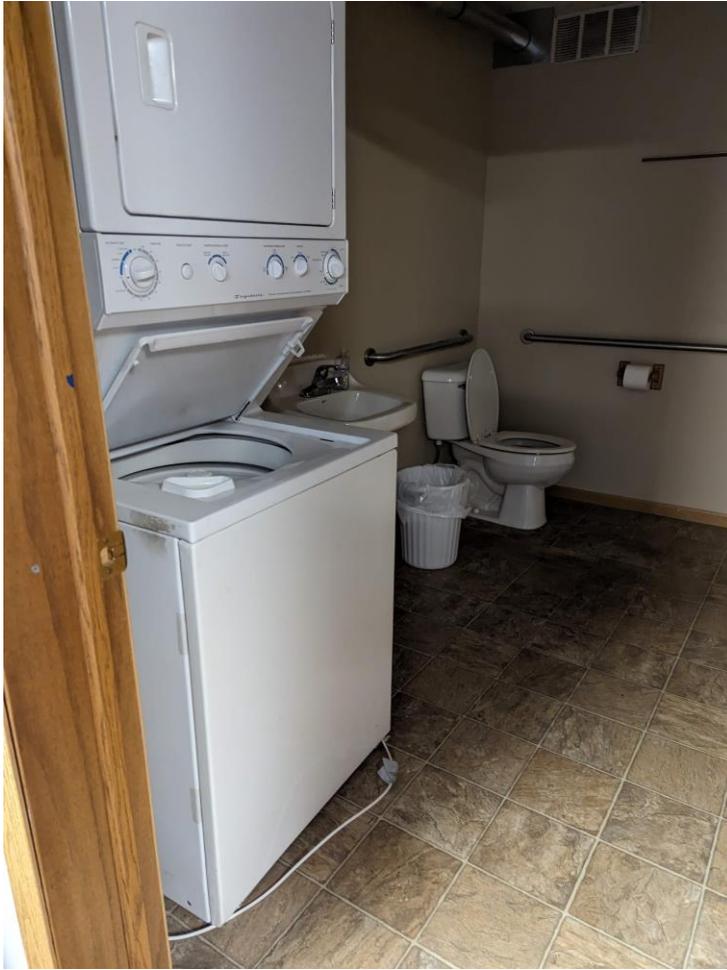
Toilet Rooms:

There are two recently renovated toilet rooms. The toilet rooms require an 18" vertical grab bar be installed to meet current ADA code.

The stackable laundry does not meet accessibility standards for reach or front clearance. The location of the laundry, at the door, blocks the required ADA clear space at door.

Additional power outlet required to remove the non-code compliant extension cord.

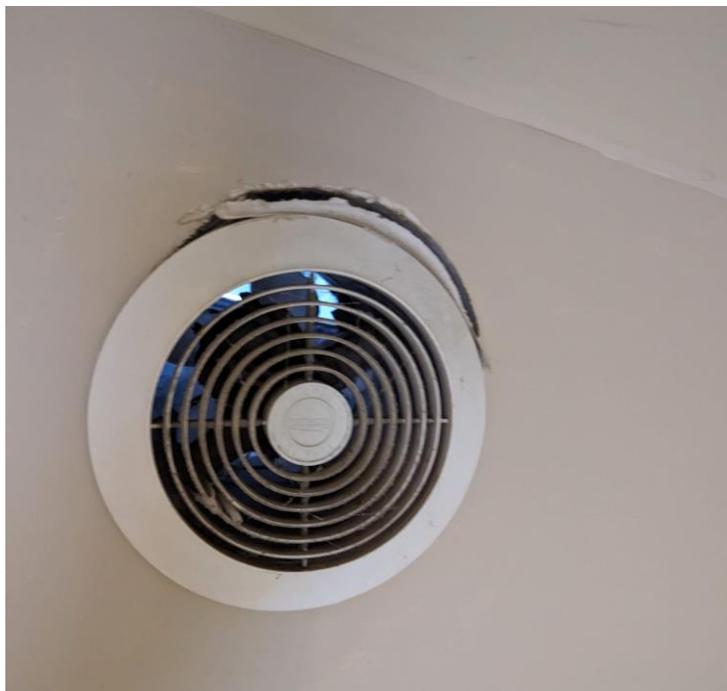
Wall vent at toilet room exhaust needs to be sealed or replaced. Exterior daylight is seen through the wall.

Previous water damage was repaired on the north wall of the building. This area has ineffective insulation at the exposed ceiling exposed to visual inspection. Vapor barrier is not in place. Per the photo, this small area was visually accessible showing a significant amount of material discoloration from previous water leaks. Visual inspections are recommended quarterly to determine if there is a change in the discoloration. If a color change or size increase is observed, mold sampling should take place.

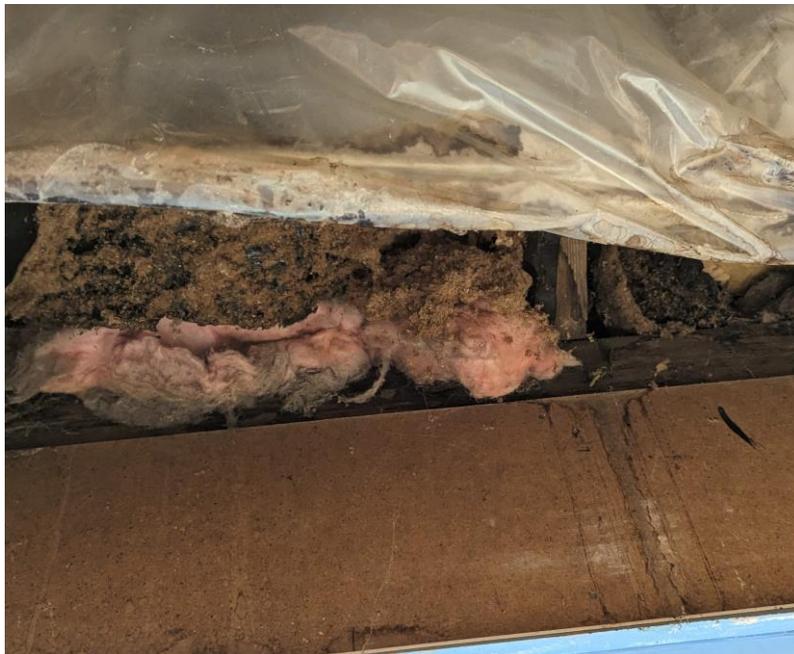
Underside of roof sheathing, missing insulation

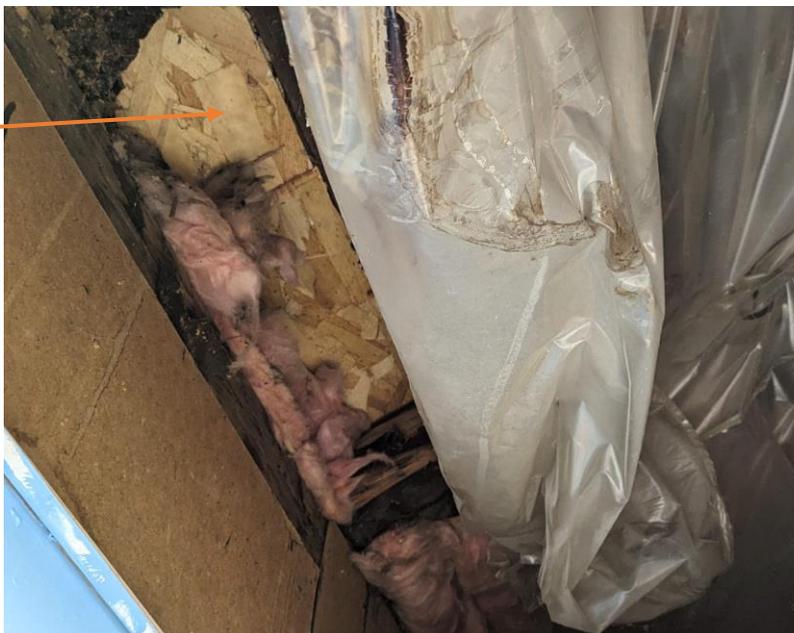
The observer has significant concerns with the energy efficiency of this building with lack of insulation, lack of vapor barriers, no air infiltration systems and multiple exhaust systems that are wide open.

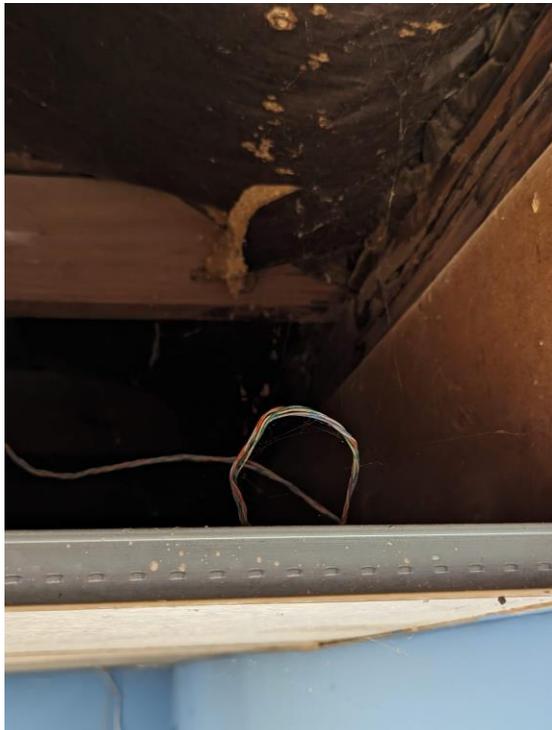
Misc. wire in ceiling. It is recommended to have an electrician inspect wiring and repair non-compliant conditions

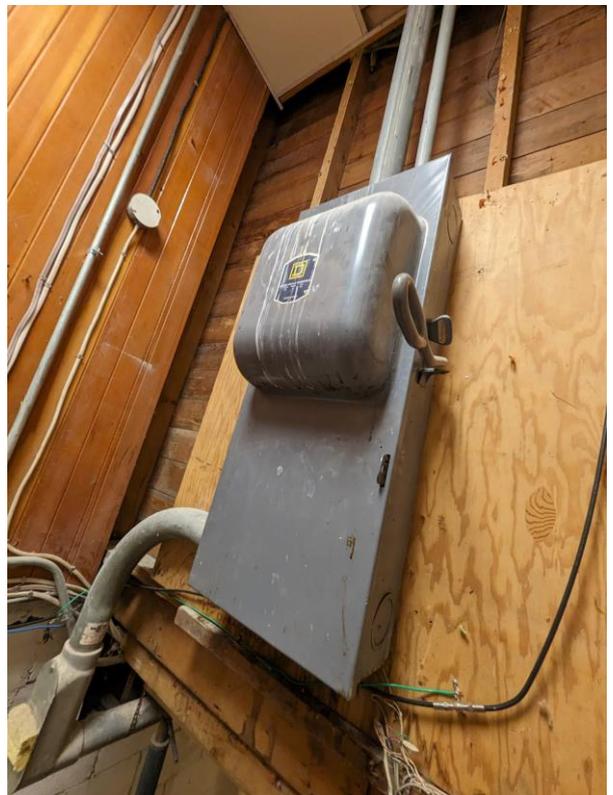
Wiring and piping in various areas are generally 'unfinished'.

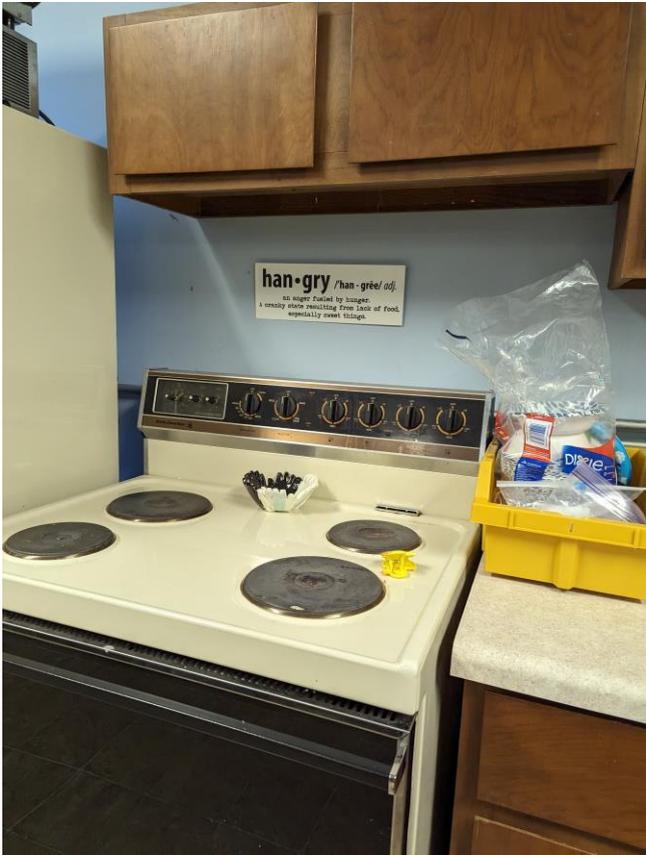
Kitchenette:

There is currently no exhaust vent for range. A code compliant kitchenette would accommodate a grease interceptor below the sink and an exhaust hood.

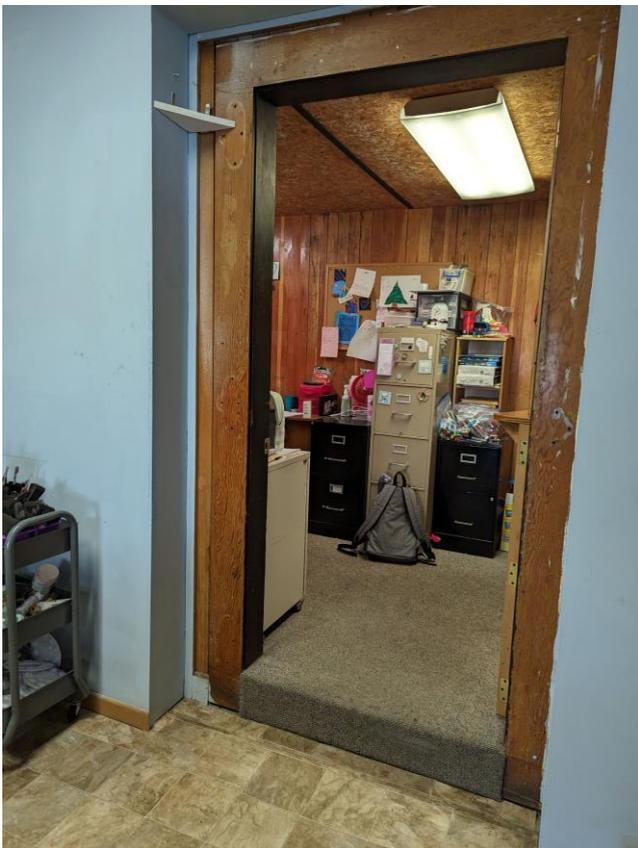
Youth Center Office: requires a step up to access. This does not accommodate employees that have mobility concerns. Best practices would recommend this be on the same level. This is not an accessibility violation, because there is another office that is ADA accessible.

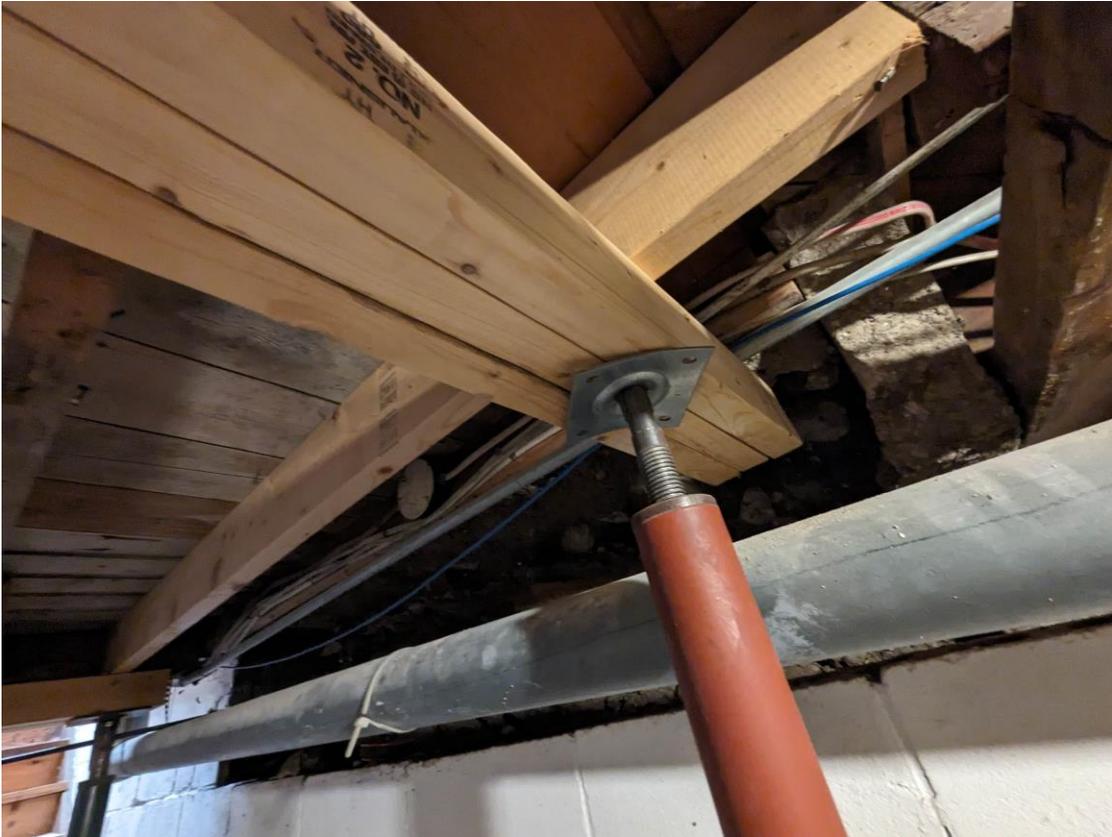
Structural: Basement column not secured, basement ceiling clearances are below the average of 7'-6" and not acceptable to occupy

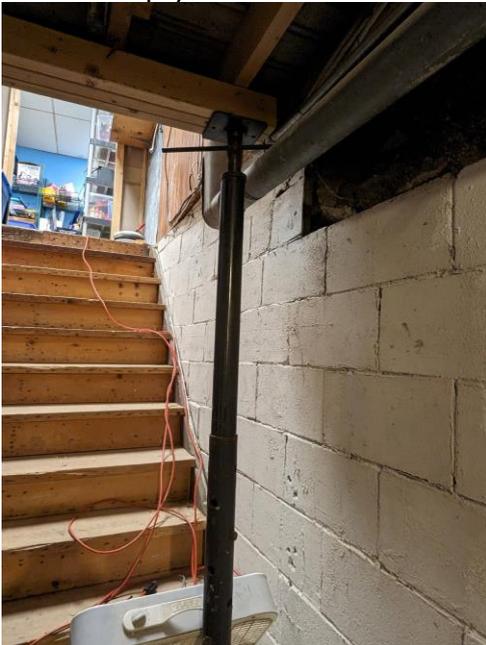
Portions of this wall are not cmu. It is some type of board. Non-code compliant stair treads are too shallow and rise is too high. There are no hand railings.

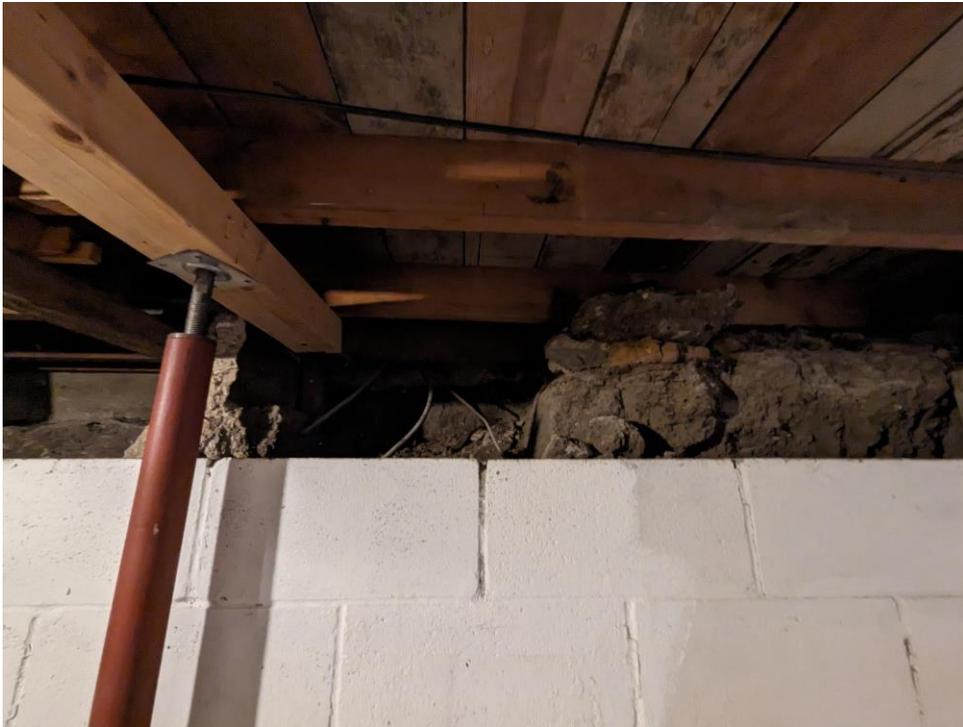
Exposed unexcavated area. Allows moisture

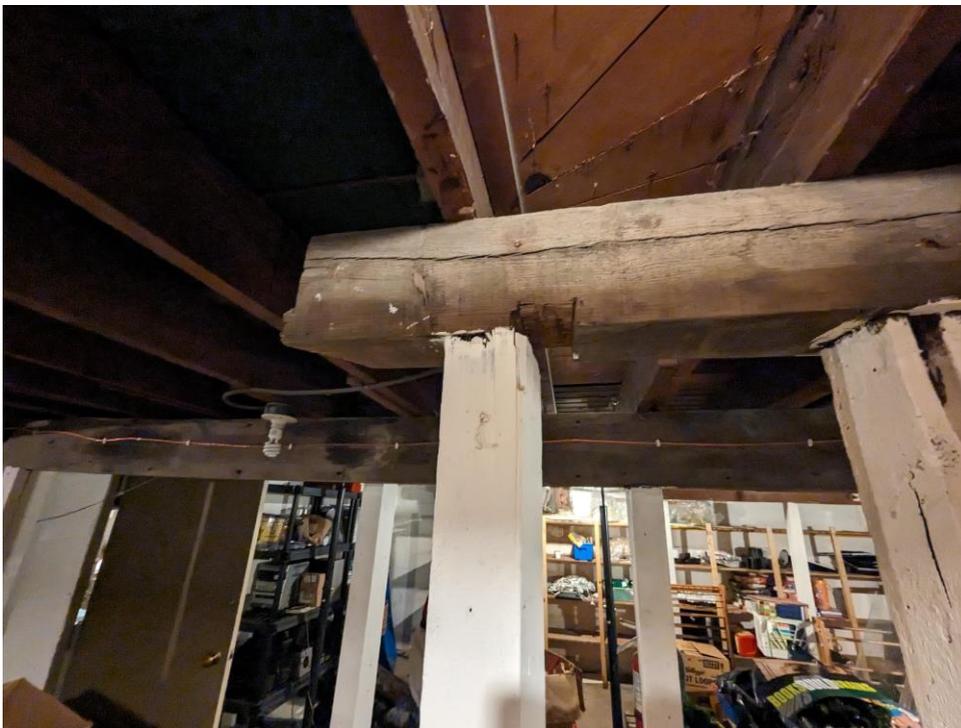
Floor loading = 100 lbs/sf - The current floor framing conditions do not meet 100lbs per square foot. Repairs and improvements need to be made.

Original beam & column support. No Hanger supports. Does not meet the required 100lbs/sf floor framing requirement

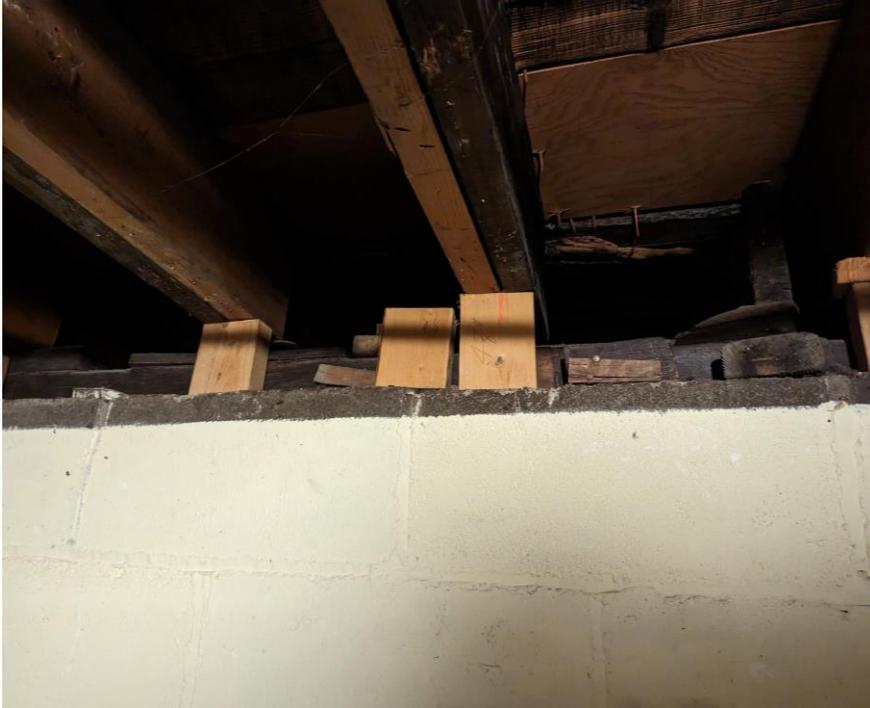
Improper blocking/supports. There are numerous first floor framing modifications that have occurred over the years. Significant maintenance and repair is recommended to accommodate the structural load requirements, 100lbs/sf, this occupancy type demands.

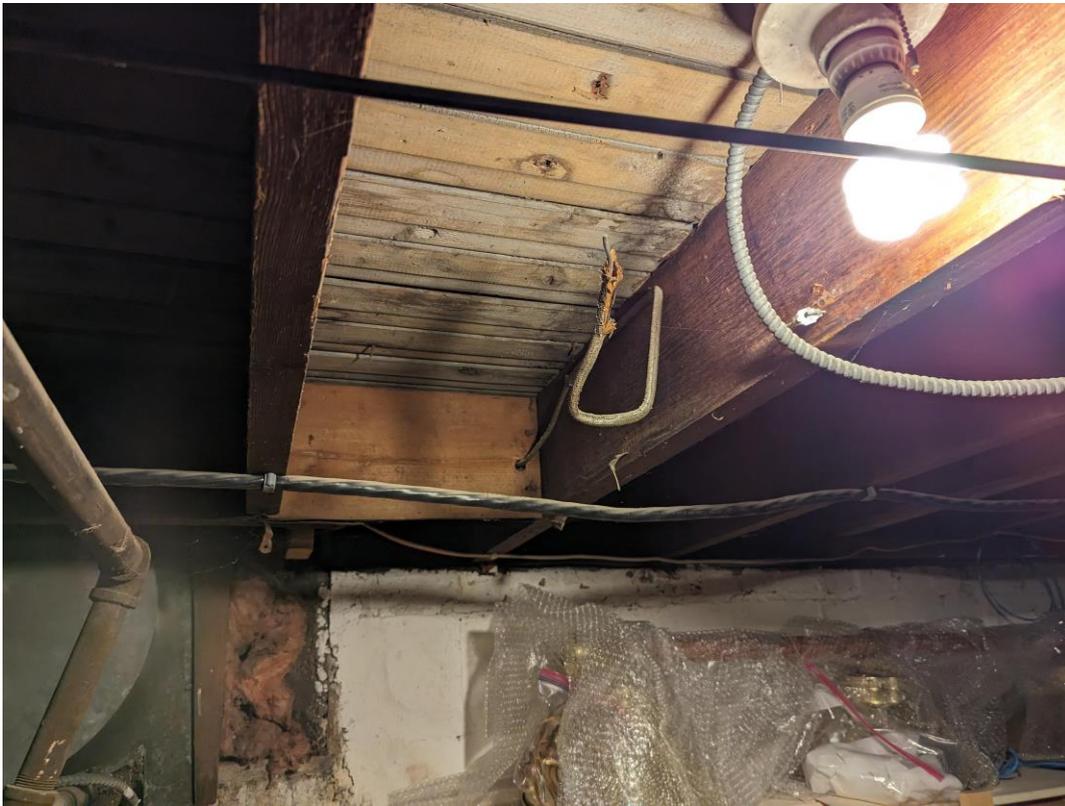
Abandoned electrical not properly terminated

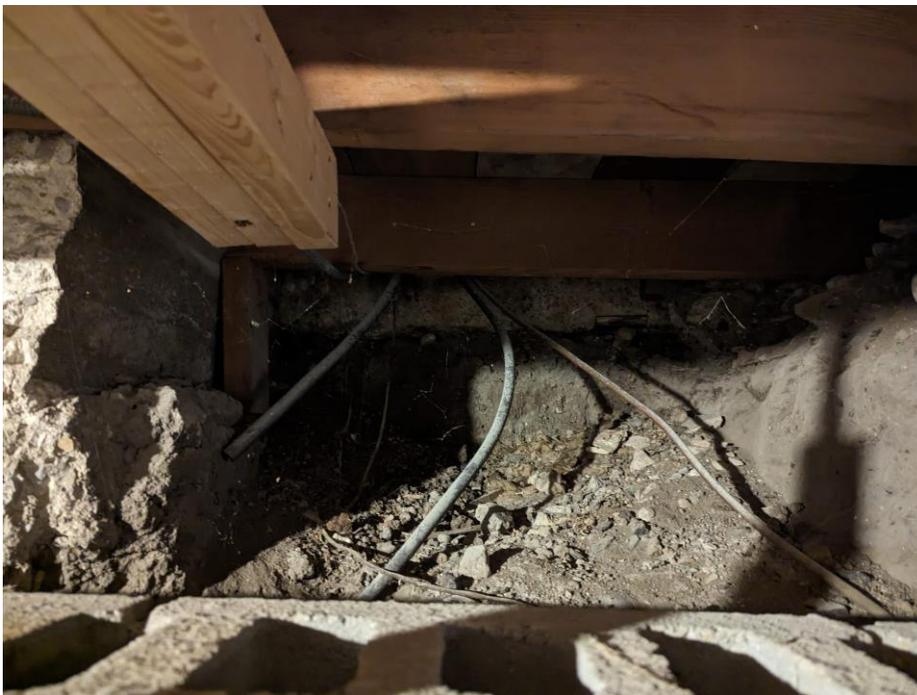
Abandoned pipes & improper supports. Slab on Grade condition is visible beyond.

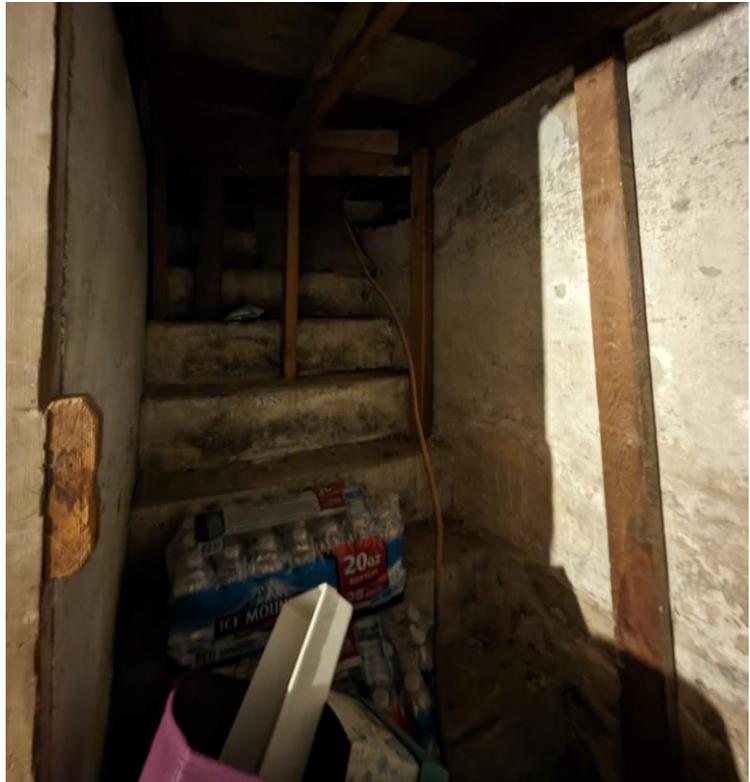
Water Heater:

Base of abandoned stair is the current location of the water heater . The water heater is 8 years old. The anticipated replacement of a water heater is every 7-12 years.

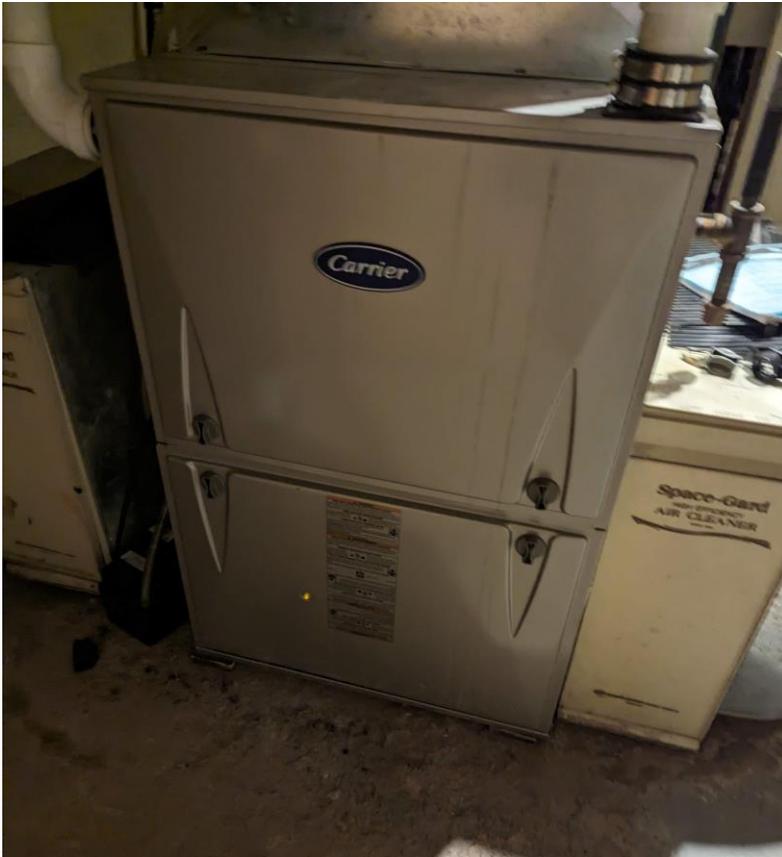
Heating and Cooling:

Newer furnace is in working order. Even when in heating, it is not able to dehumidify the building. Four dehumidifiers were working around the clock in the month of December.

The Aware office is a all in one unit that provides both heating and cooling, referred to as a P-TAC (Packaged terminal air conditioner) unit. This supplemental unit is not energy efficient and has a high electrical usage.

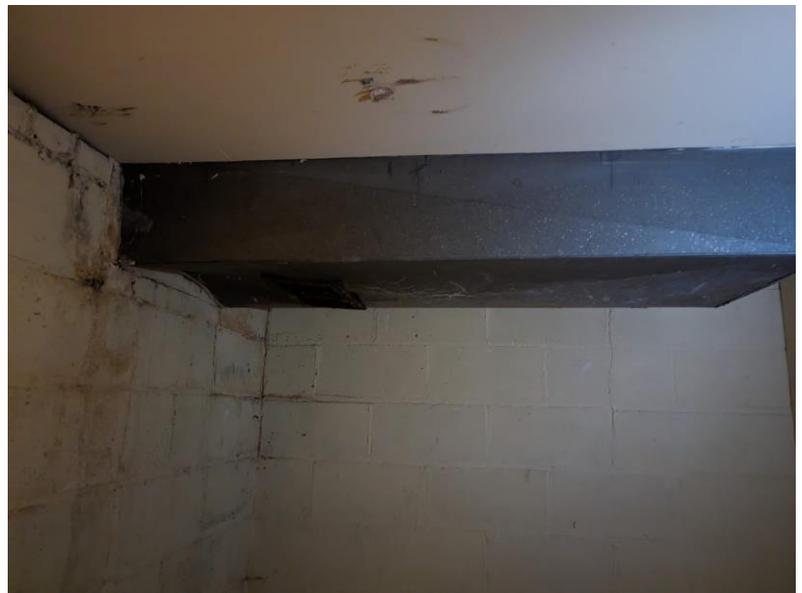
Could not follow/trace duct to main level as interior foundation wall ended. This is one of the challenges with the basement space, unexcavated spaces and even slab on grade areas.
