City of Evansville
Youth Center Board Meeting
Evansville Youth Center, 209 South First Street
Monday, March 25th, 2024, 5:30 pm

Evansville Youth Center Conditions Assessment

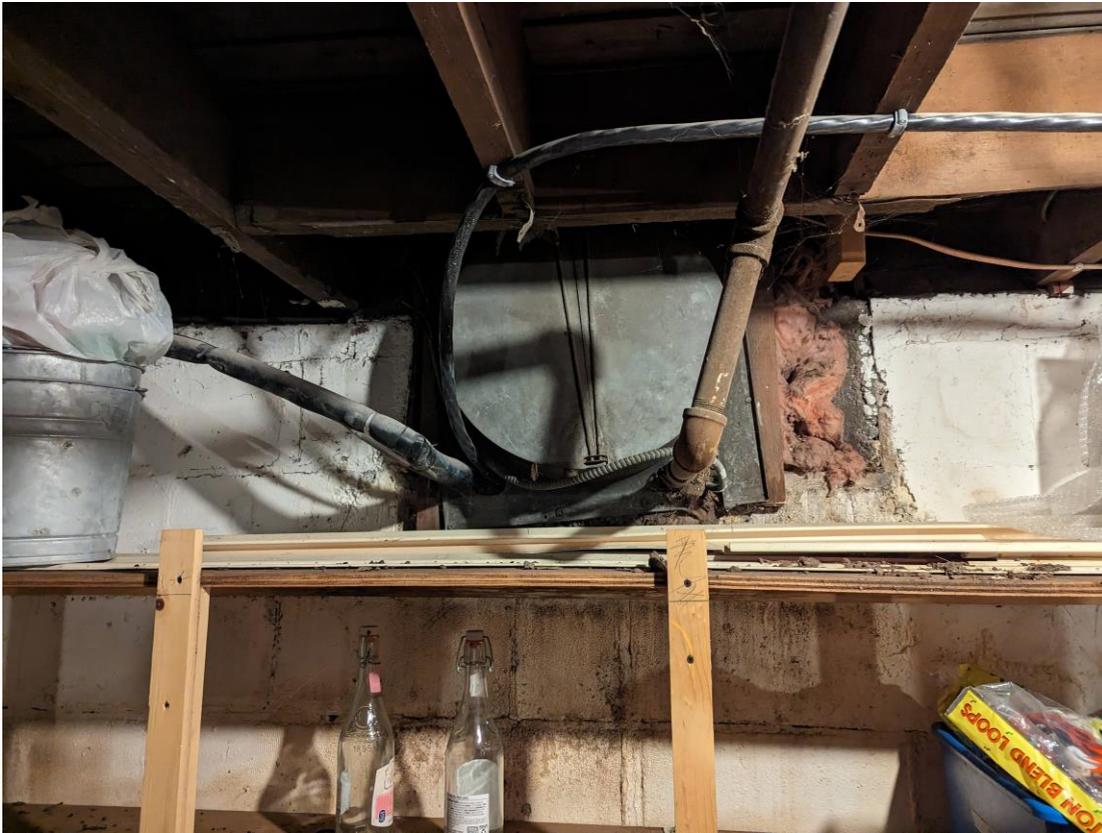
Basement mechanical chase to outside, south wall. Water stains down wall show evidence of water infiltration in the past.
