City of Evansville **Municipal Services Committee**Regular Meeting City Hall, 31 S Madison St., Evansville, WI 53536 Tuesday, March 26, 2024, 5:00 pm

- A. Aquatic Center, Splash pad, and Park Improvement Updates (Placeholder)
- 12. Upcoming Meetings
 - A. Tuesday, April 30th, 2024, at 5:00pm
- 13. Motion to Adjourn

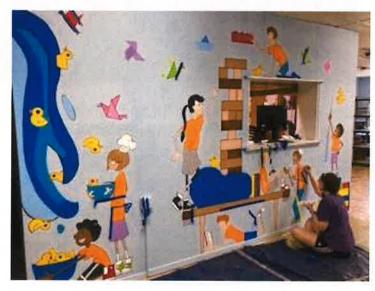
The Youth Center's common activities include: arts and crafts, snacks, games (pool, air hockey, fooseball, ping pong, shuffle board), board games, puzzles, watch movies, video games, legos, homework, computers.

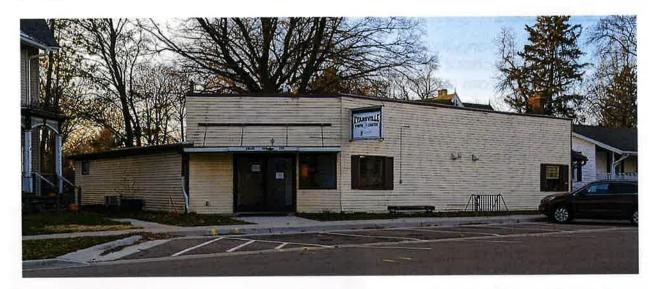
Site Amenities: Angled Street Parking is provided. ADA curb cut is located south of the site. No identified ADA parking for the building. Bike rack is provided, however it is on grass with no hard surface below. Bench is provided.

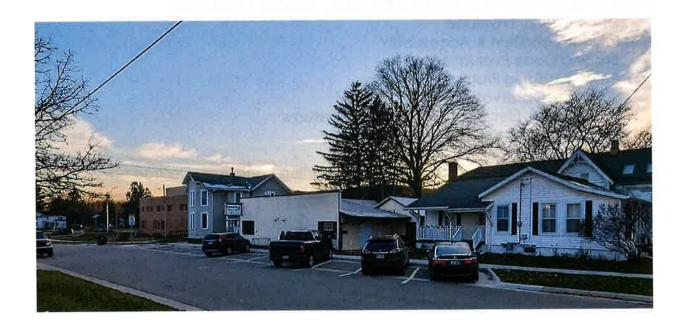
Exterior Envelope Condition

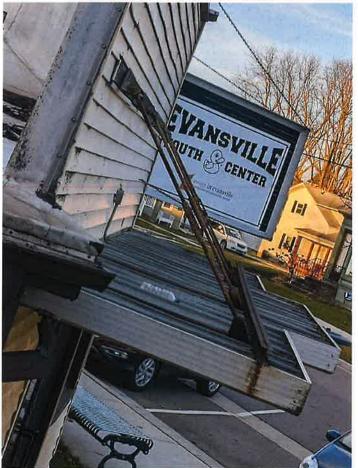
The structure is a mix of 4 to 5 buildings/additions combined. Some with basement space, unexcavated areas and others with the building extended over slab on grade conditions. Exterior is vinyl sided on street side. Rear side is combination of wood and pressed board siding.

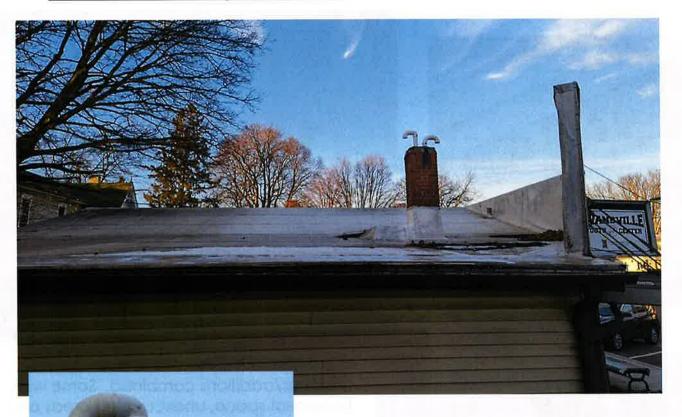
Roofing – there is a TPO white membrane on the roof. The roof framing displays evidence of unbraced and undersized members. There was evidence of water leaks in areas throughout the roof. Now fixed, however was detrimental to the structure and insulation is missing, damaged and underperforming.

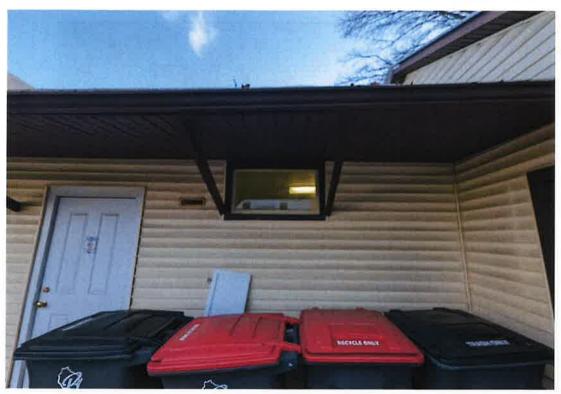
The north roof overhang is sagging. The existing bracing is not properly reinforcing the roof framing. The trash cans being located on the side yard is a visual eyesore.

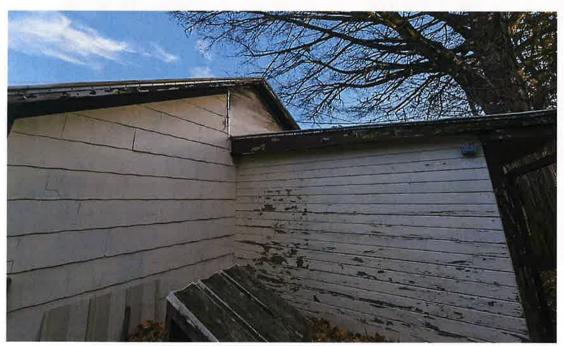
The rear of the youth center is a combination of pressed siding and wood siding. The fascia's all have significant wood rot. The exterior is poorly maintained and an eyesore to the adjacent property owners.

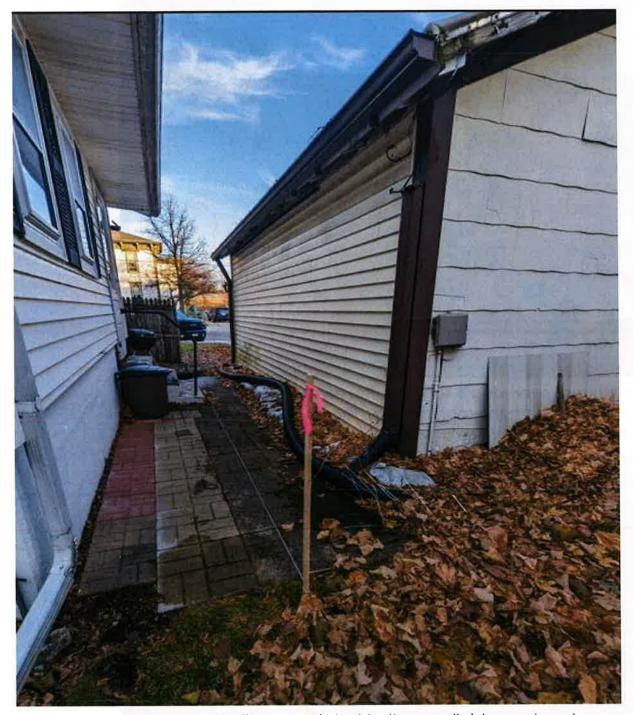
This image shows many challenges related to the small side yard and water management. The side yard is very tight, the grading is flat and pitching toward the EYC, rubber hoses are attempting to move water to the street, sand bags have been placed on the base of the wall (under the leaves) to control water. This condition is allowing water infiltration into the EYC building. This is not an acceptable long-term solution.

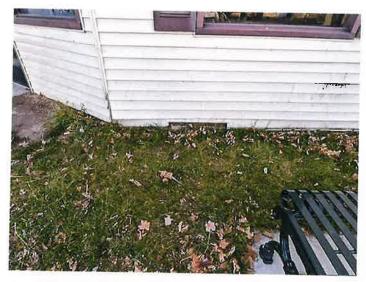
The site is flat, there is no positive grading away from the building, water susceptible building materials are deteriorating and too close to grade. 8" above grade for wood is required by code.

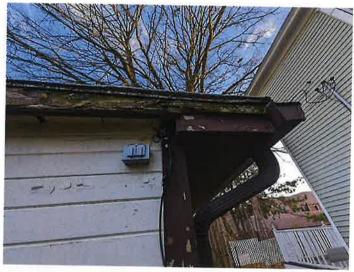
Excessive wood rot. Electrical was added to this location and it appears to have electric heat tape to avoid ice damming. This is a water infiltration area due to lack of insulation and modifying an old 'garage' into an interior space.

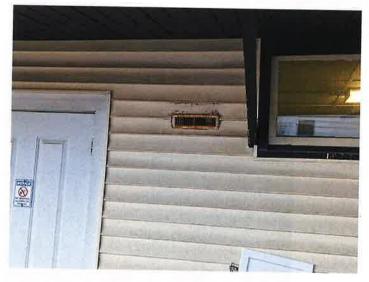
Rusted exterior exhaust vent. The building has many abandoned exterior penetrations, reflecting a concern for moisture migration through the exterior envelope and poor energy efficiency.

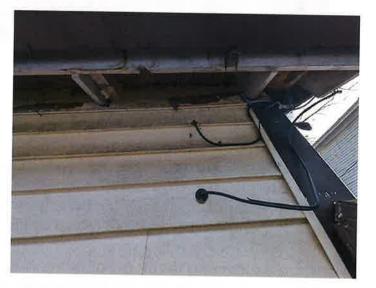
Perimeter of the building has various abandoned wires and heat tape. Electrical Services is in the rear of the building, overhead. Access is limited with the side yard of less than four feet.

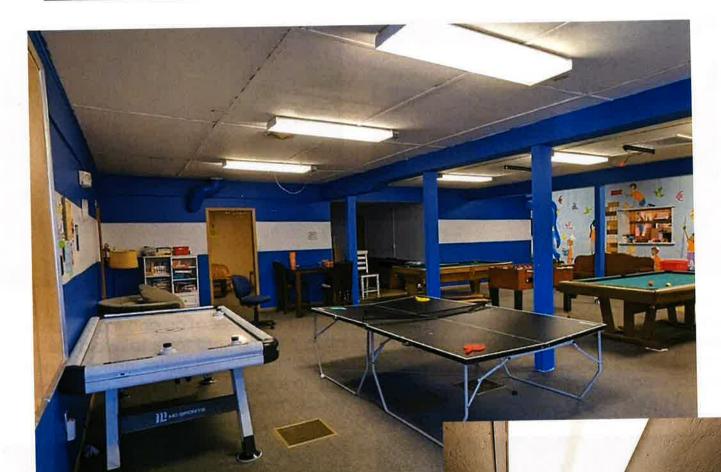
The existing 2500sf youth center provides services to a maximum of 40 students. Above is an image of the EYC open game area. The flooring is carpet, walls are drywall, and ceilings are wood panel board with surface mounted fluorescent lighting. The HVAC system supplies through the floor from the basement. There is a distinct odor of dampness upon entry into the building. There are multiple dehumidifiers on the main level, constantly running annually to address elevated levels of moisture in the building. Damp interior spaces create poor indoor air quality. There was no discoloration of materials observed during the December 2023 walk-thru. The moisture is assumed to be originating in the foundation/ basement area. Monitoring of indoor air quality and visual inspections for mildew are recommended.

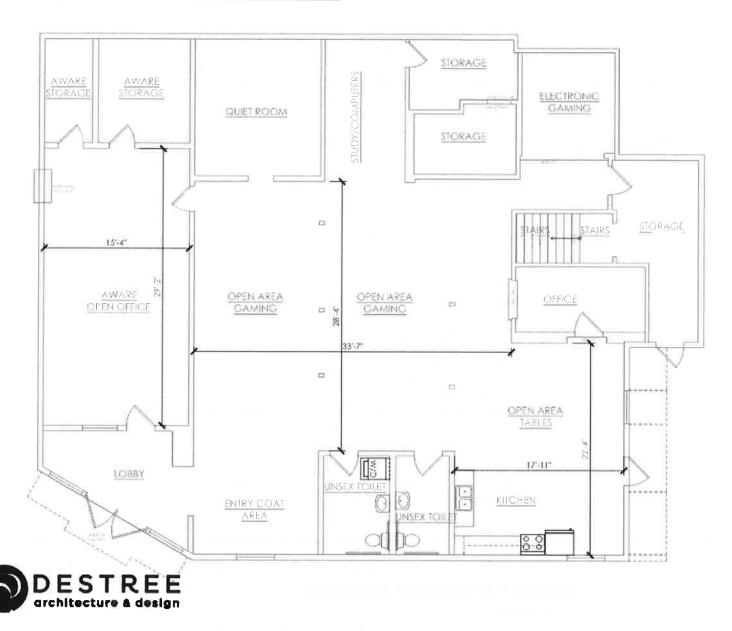
Existing Main Level = 3520 sf footprint

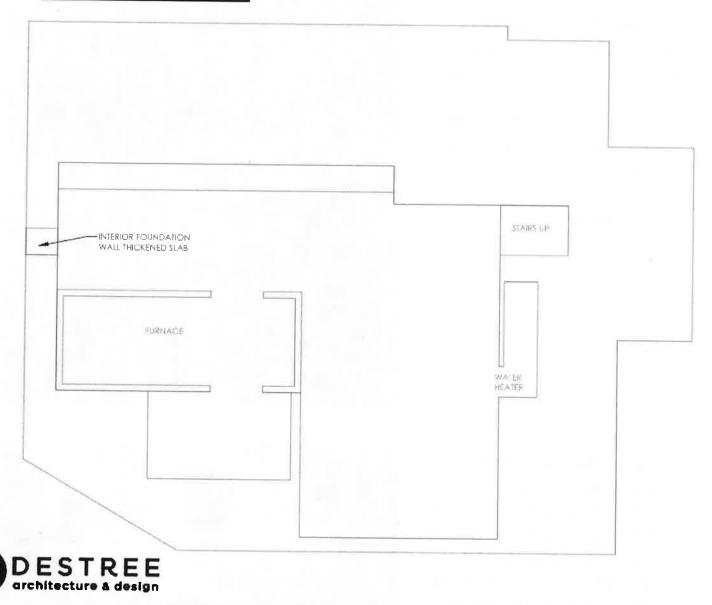
Existing Basement = 1435 sf footprint

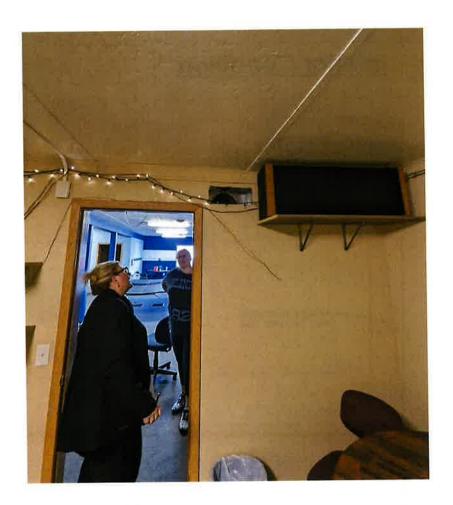
Supply grill missing at duct. Door opening is 32" wide. Noise is a concern with the adjacent game area. A new 36" door will need to be installed to accommodate accessibility clearances.

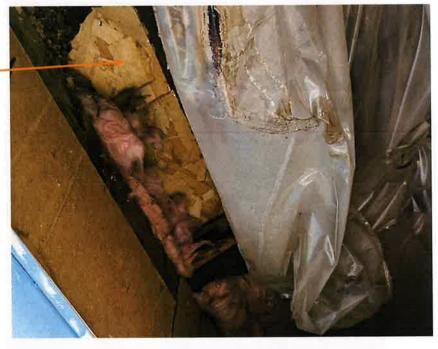
The observer has significant concerns with the energy efficiency of this building with lack of insulation, lack of vapor barriers, no air infiltration systems and multiple exhaust systems that are wide open.

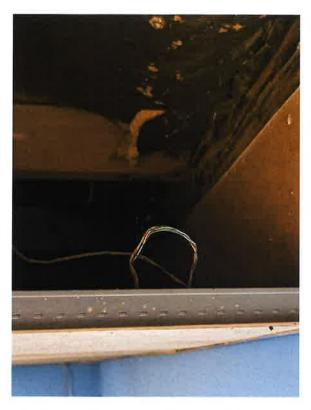
Misc. wire in ceiling. It is recommended to have an electrician inspect wiring and repair non-compliant conditions

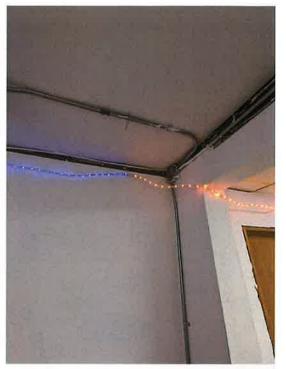
Wiring and piping in various areas are generally 'unfinished'.

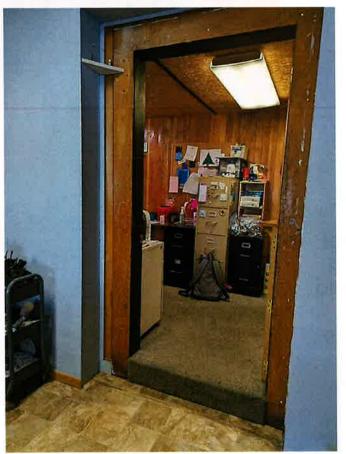
Youth Center Office: requires a step up to access. This does not accommodate employees that have mobility concerns. Best practices would recommend this be on the same level. This is not an accessibility violation, because there is another office that is ADA accessible.

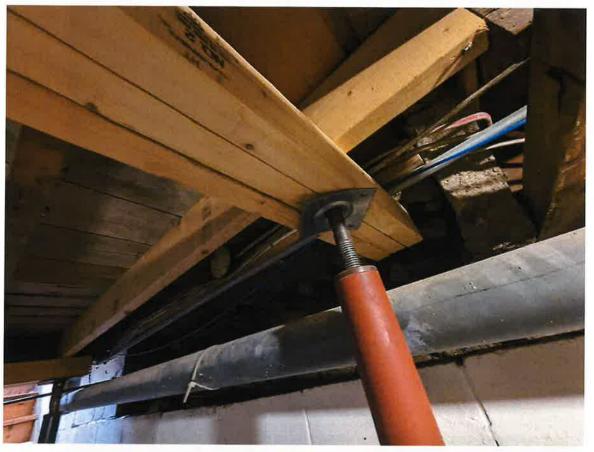
Structural: Basement column not secured, basement celling clearances are below the average of 7'-6" and not acceptable

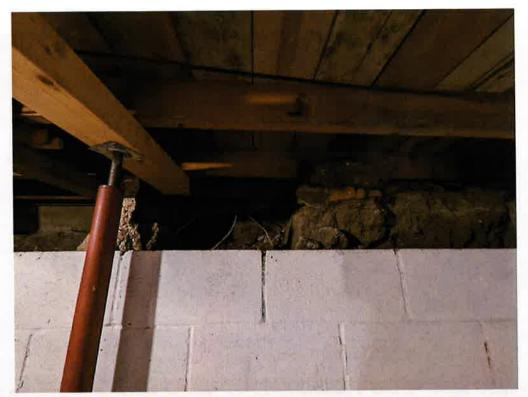
Exposed unexcavated area. Allows moisture

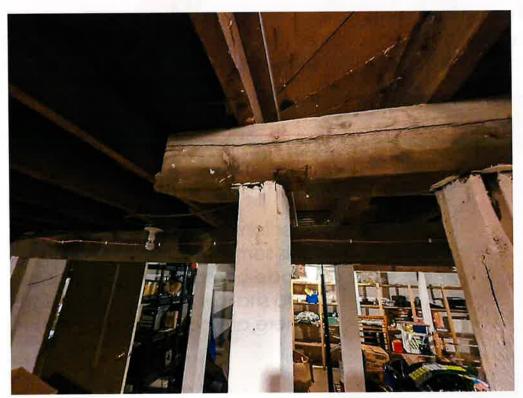
Original beam & column support. No Hanger supports. Does not meet the required 100lbs/sf floor framing requirement

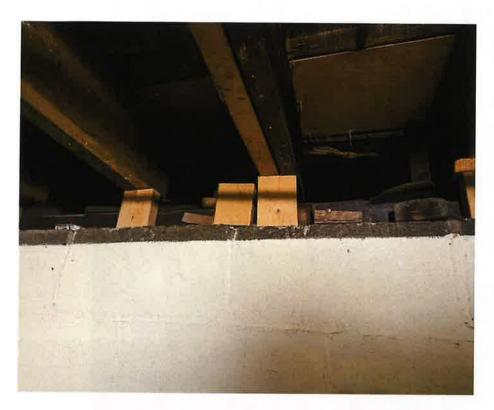
Improper blocking/supports. There are numerous first floor framing modifications that have occurred over the years. Significant maintenance and repair is recommended to accommodate the structural load requirements, 100lbs/sf, this occupancy type demands.

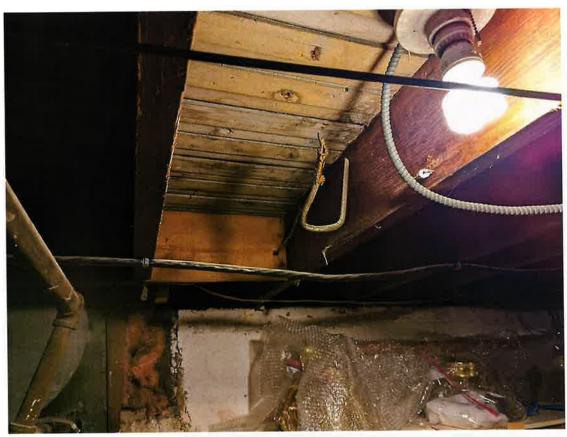
Abandoned electrical not properly terminated

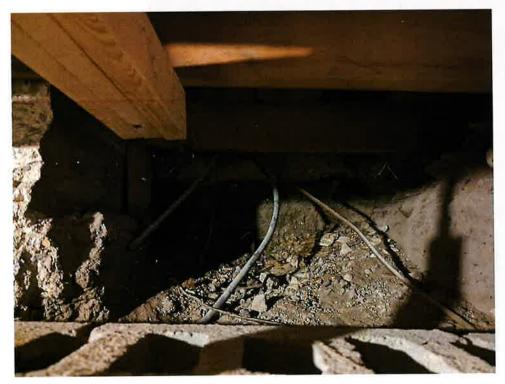
Abandoned pipes & improper supports. Slab on Grade condition is visible beyond.

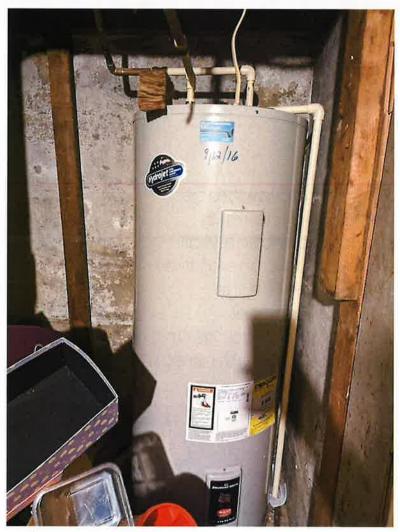
Evansville Youth Center – Conditions Assessment 209 S. First St Evansville, WI Destree Design Architects, Inc.

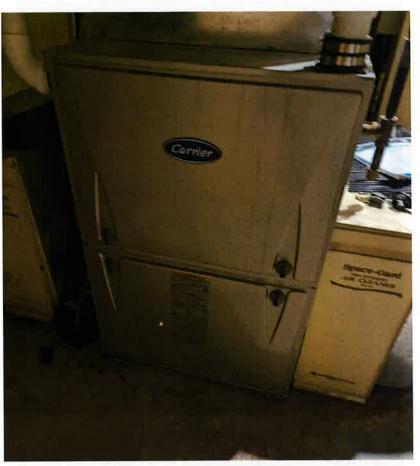
Heating and Cooling:

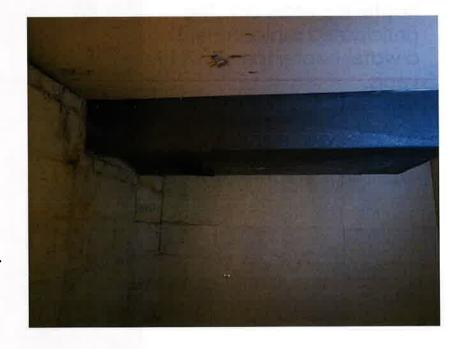
Could not follow/trace duct to main level as interior foundation wall ended. This is one of the challenges with the basement space, unexcavated spaces and even slab on grade areas.

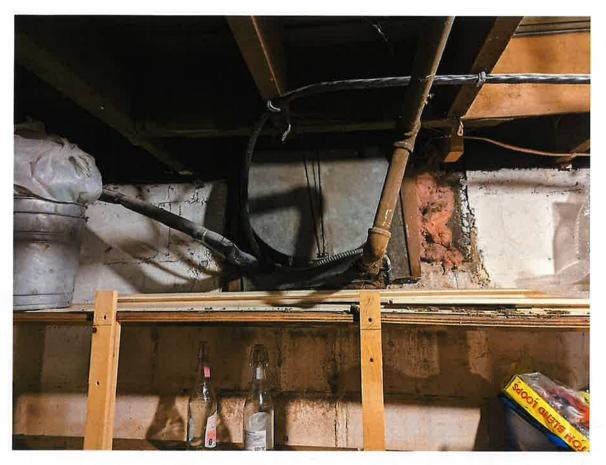
Basement mechanical chase to outside, south wall. Water stains down wall show evidence of water infiltration in the past.

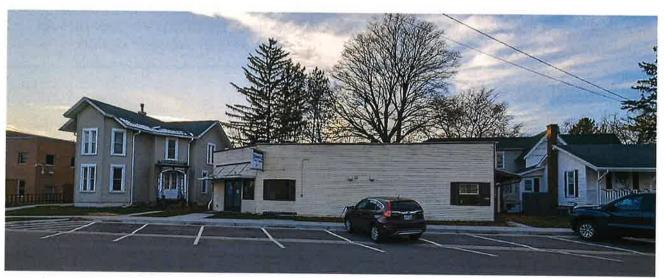
Exterior image of the Evansville Youth center and adjacent properties.
