City of Evansville
Youth Center Board Meeting
Evansville Youth Center, 209 South First Street
Monday, March 25th, 2024, 5:30 pm

Evansville Youth Center Conditions Assessment

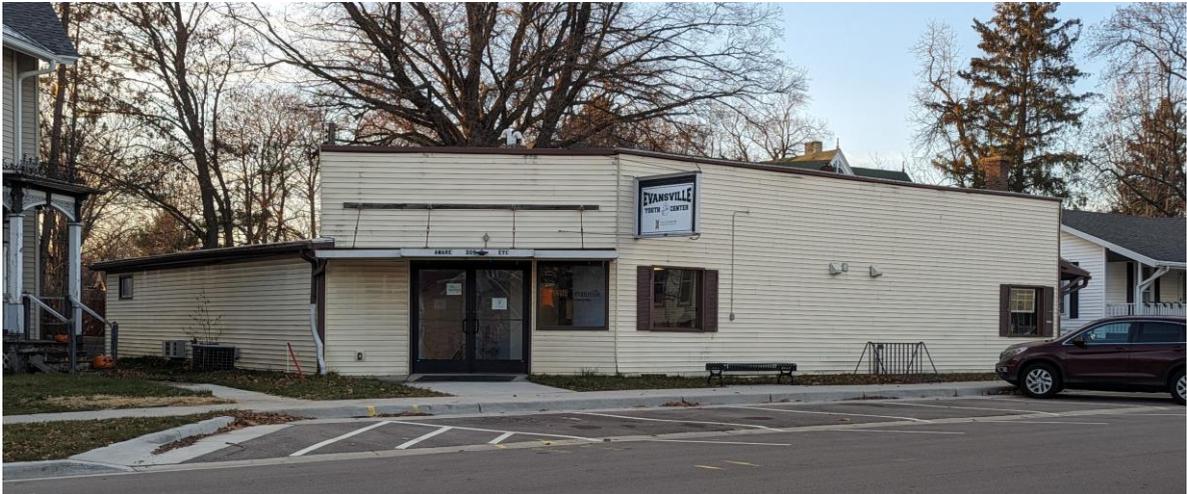
Site Amenities: Angled Street Parking is provided. ADA curb cut is located south of the site. No identified ADA parking for the building. Bike rack is provided, however it is on grass with no hard surface below. Bench is provided.

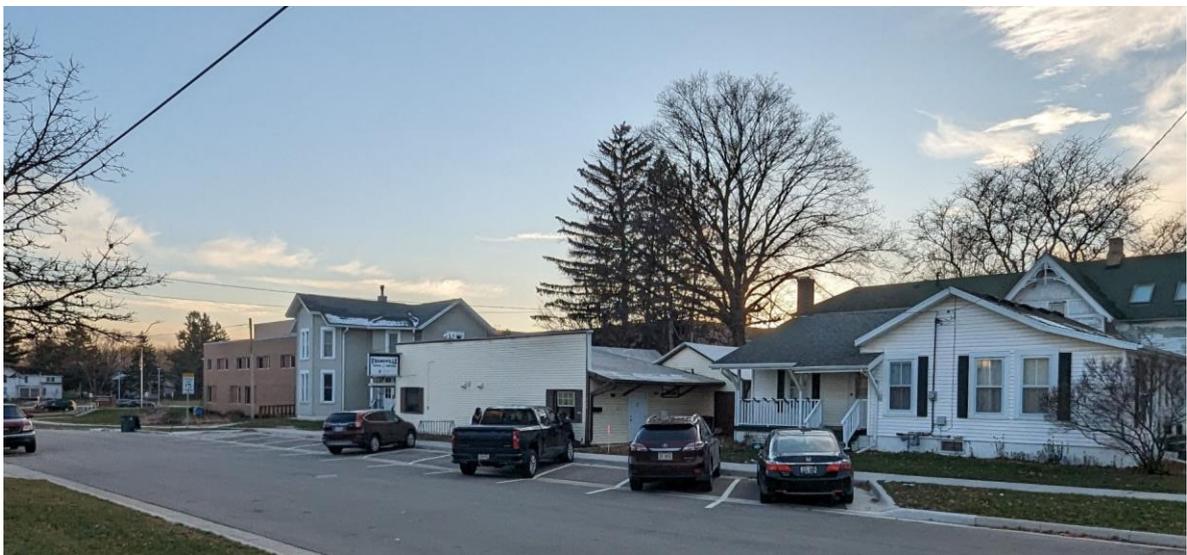
The Youth Center is nestled between two residential buildings. Both of these residential buildings are zoned B-1. There is no immediate open green space or exterior gathering area. Activities are interior. The site has water management challenges. The side yards and rear yards are narrow. The access and water management on the side yards should be considered if and when the building is renovated or re-built.

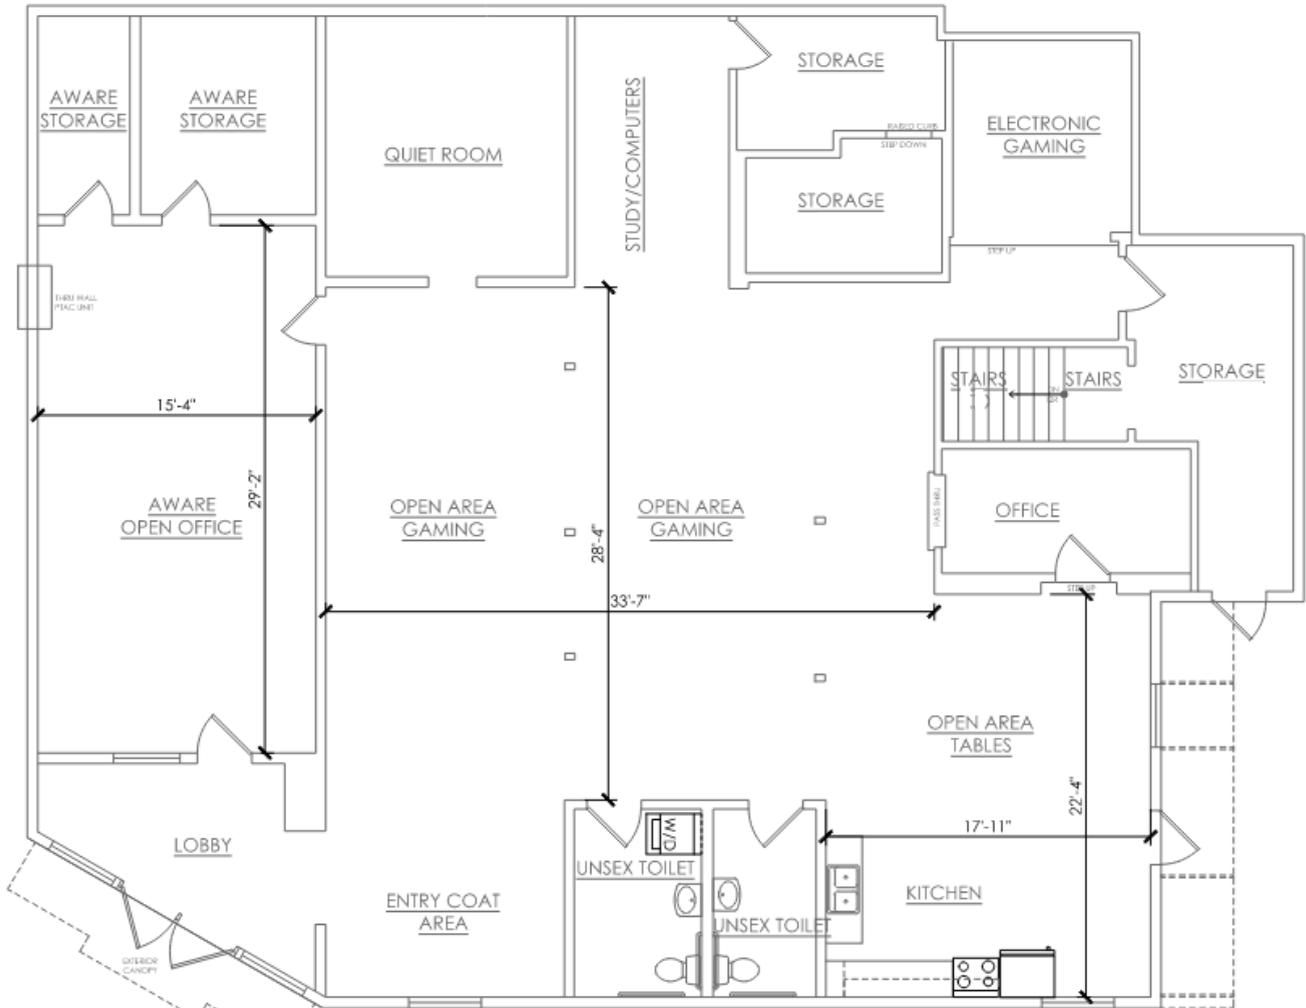
Existing Main Level = 3520 sf footprint

Floor loading = 100 lbs/sf - The current floor framing conditions do not meet 100lbs per square foot. Repairs and improvements need to be made.

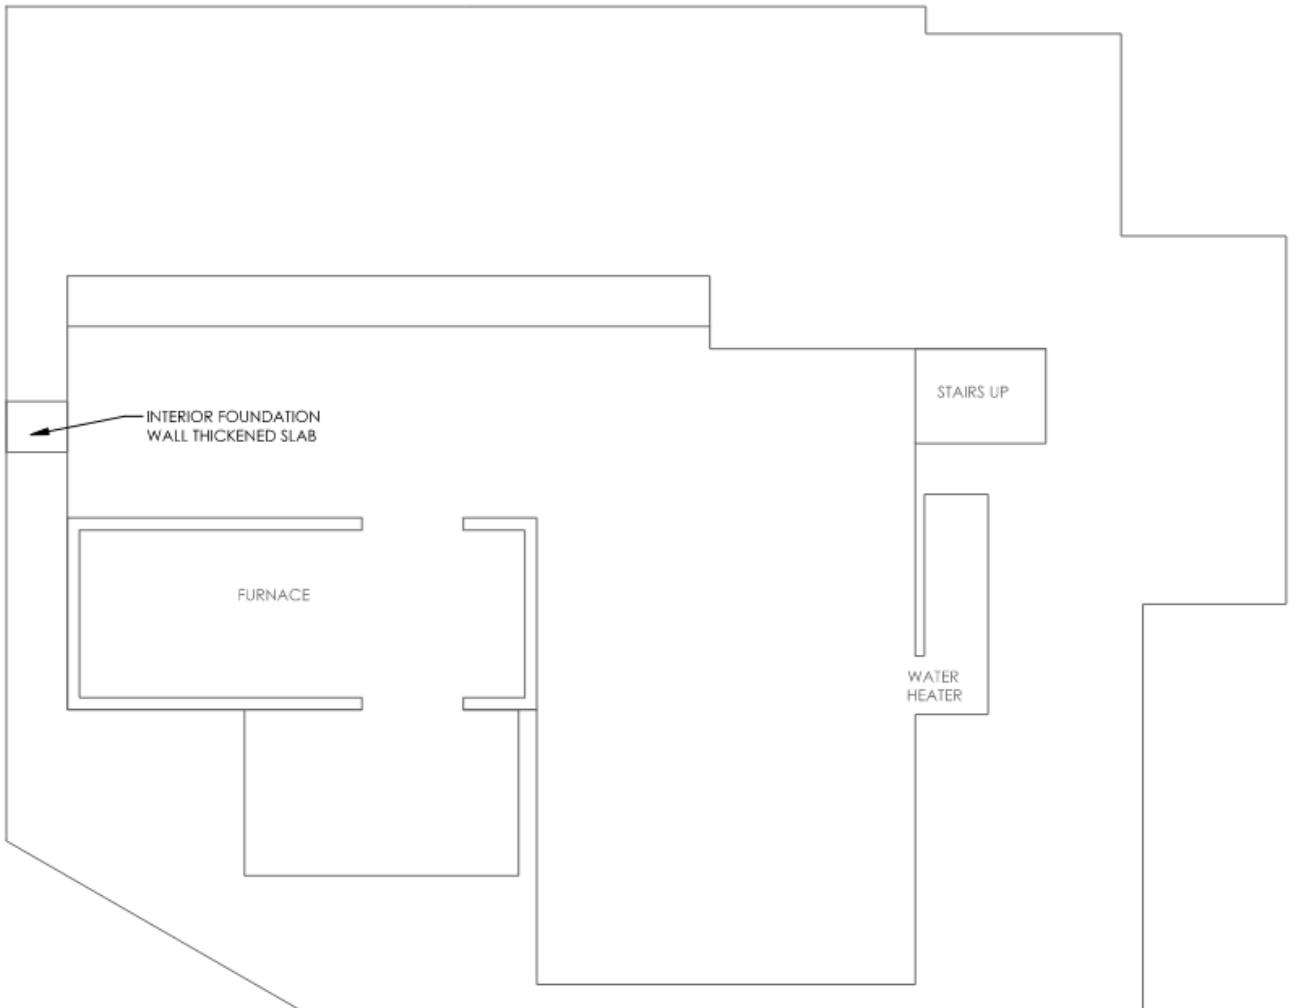
Existing Basement = 1435 sf footprint

The basement has a noncompliant stair and rail condition. Headroom is noncompliant. The basement has piecemealed structural systems that do not meet current structural code. Structural improvements should have been completed when the retail building was renovated into the youth center .

The basement has significant moisture and water issues. The space should not be used as storage. There is standing water on the slab after all rains. Unexcavated areas are not encapsulated with vapor retardant materials, soil is visible in the basement. There is a significant mildew odor due to water infiltration. Additional observations are identified in the following pages.

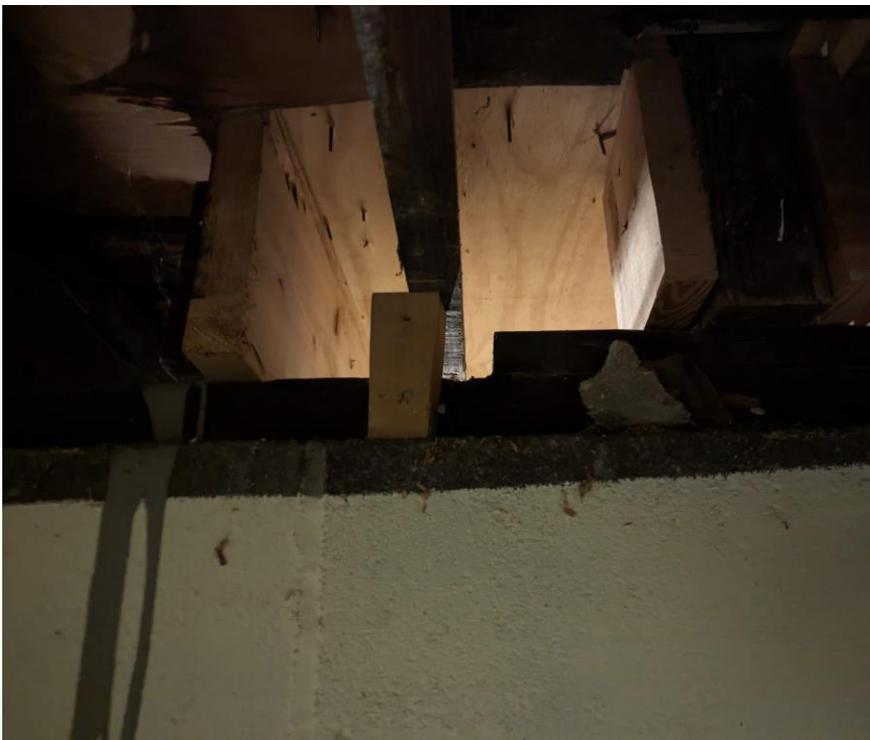
Improper blocking/supports. There are numerous first floor framing modifications that have occurred over the years. Significant maintenance and repair is recommended to accommodate the structural load requirements, 100lbs/sf, this occupancy type demands.

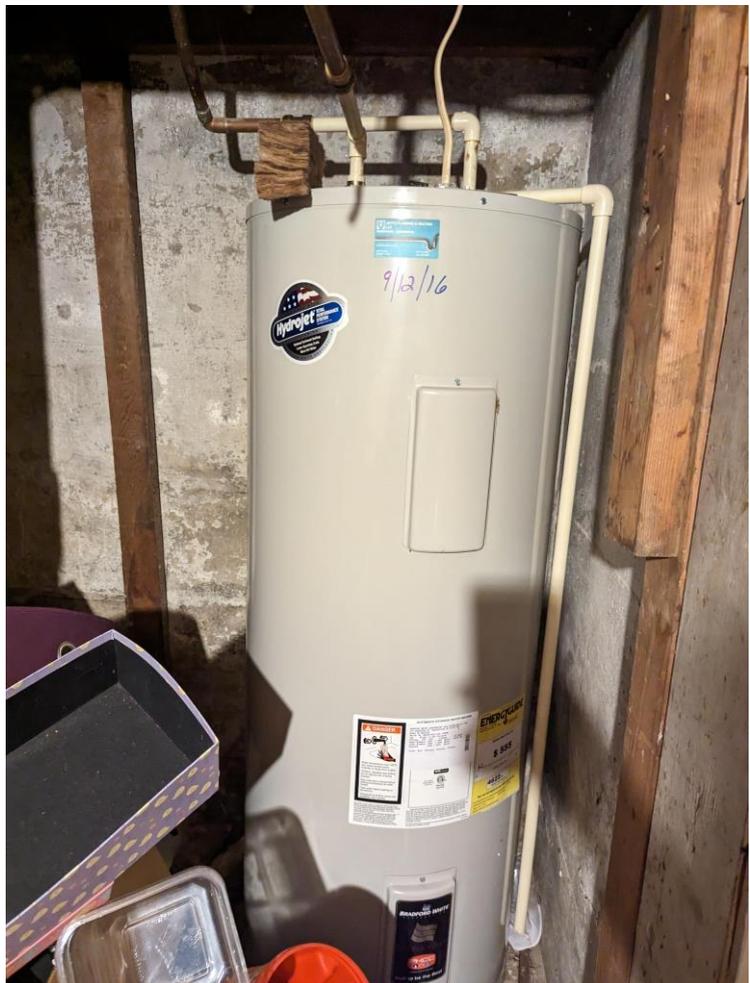
Base of abandoned stair is the current location of the water heater . The water heater is 8 years old. The anticipated replacement of a water heater is every 7-12 years.
